Case Study: The Problem of Leakage in Residential Buildings and Mitigation Strategies

Harjot Kaur

Abstract: *This case study involves finding the source of leakage and seepage in a ceiling of a room in a penthouse located in posh Versova area of Mumbai, the top metropolitan city of Maharashtra state in India. Running water has been detected on one of the ceilings of a room on level 1 of the penthouse. This case study explores and studies different suspected sources of leakage and moisture and also studies each source in-depth to zero-in the source of water. The study also explores potential causes, including structural anomalies and concealed pipelines, and proposes comprehensive waterproofing and repair strategies to mitigate the problem. The findings emphasize the importance of proper maintenance and timely intervention to prevent long term structural and health hazards in residential buildings.*

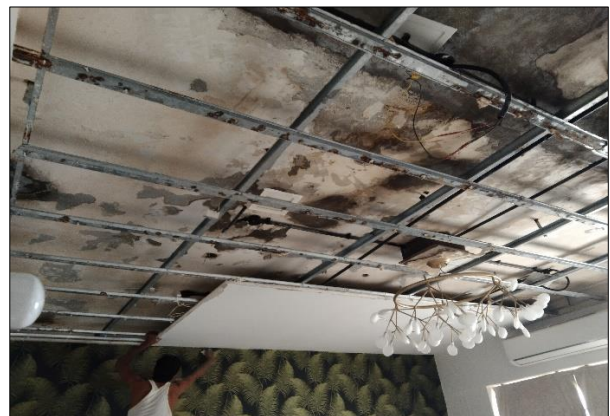
This case study explores the problem of seepage in level 1 of a three-story penthouse located on the 14th, 15th and 16th floors of high-rise building in Mumbai city in India. The problem surfaced when a gyroc ceiling lost its strength due to presence of moisture and water and fell down-a serious life and health hazard. The subject ceiling is depicted in figure... Upon inspection we could clearly see huge signs of water leaking from the slab. However, we were informed there is a room above this room, with no water connections. Our task now was to find out other sources of water inlets, resulting into this sever water leakage.

Figure 1: Condition of the Subject Ceiling on Level 1

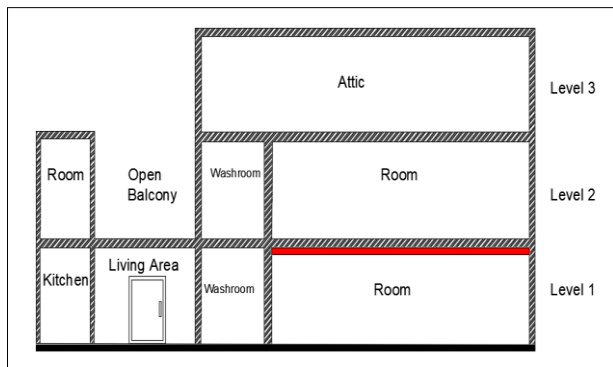
AutoCAD elevation is shown in Figure 1 of this case study. Leakage has been detected on the ceiling of a room on level 1 of the Penthouse. This ceiling has been marked in red in figure 1 for the sake of clarity.

Figure 1: AutoCAD Elevation of the Penthouse

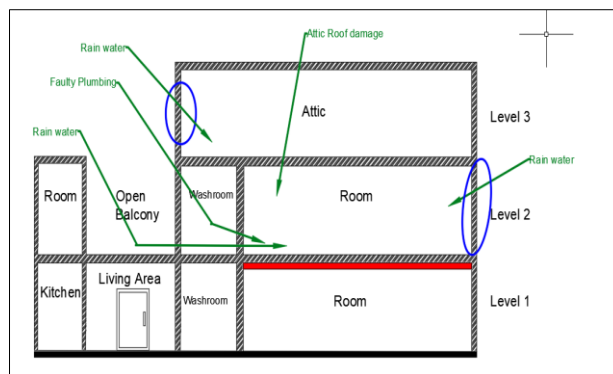
The following figure, i.e. figure no 2, depicts all the possible sources of leakage which could be a reason for seepage from the subject ceiling. In this section we shall discuss each reason one and one and why we reason out that these could be the cause of seepage in the subject ceiling.

Figure 2: Marking of suspected Sources of Water

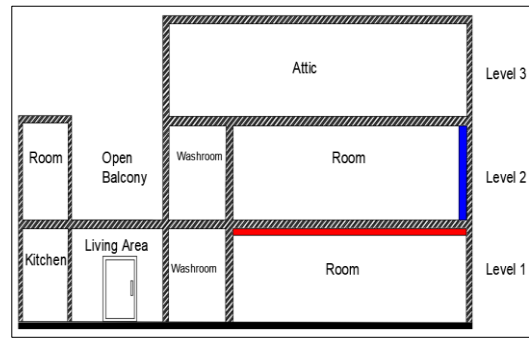
Figure 3: Window On Level 2

However, there is a huge French window in the room as shown in Figure 3, which does not have proper structured or a temporary awning outside the wall, meant to prevent rain water to enter the room during monsoons.

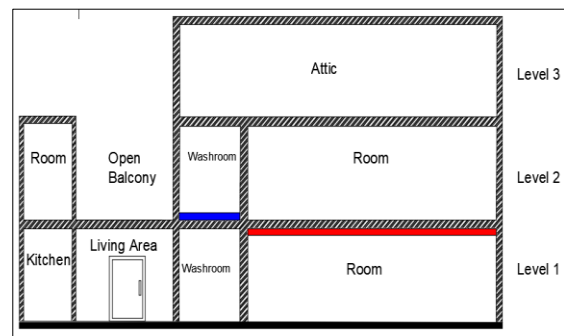
The second source of seepage in the subject room can be the washroom attached to the room above the subject room. There could be two possible sources of water leakage from this washroom. The first could be faulty underfloor plumbing, which could be releasing water to the surrounding areas, and this water could be leaking from the slab to the room below.

Figure 4: Washroom Above the Subject Ceiling

The second source could be faulty or absent waterproofing membrane in the washroom. We suspect that waterproofing has not been done in the sunk area properly due to which ant water or moisture must be leaking into the slab and reaching the ceiling of the subject room.

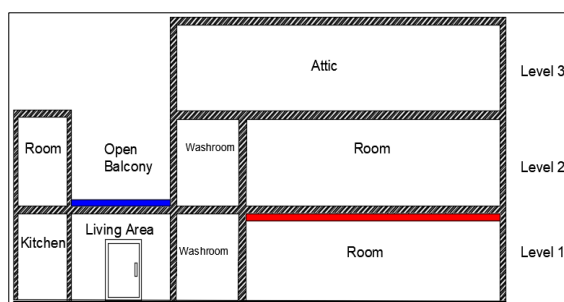
The next source of water could be the open balcony adjoining the washroom on level 2. This balcony has old flooring, numerous tiles and broken and grouting is missing.

Figure 5: Adjoining Balcony on Level 2

The skirting is also missing at many places and thus our team thinks that there could be many pathways through which the water could be seeping into the slab underneath, making its way to the ceiling of the subject room.

Next we started inspecting the open balcony adjoining the washroom on Level 2. The suspicion started from the fact that when we broke the flooring of the washroom and found out that the plumbing of the underground pipes was faulty, we suspected that there is high probability that concealed plumbing in the walls would also be faulty, since it had been done by the same team of plumbers. Therefore, we un-plastered the walls of the washroom and found out that there is a high amount of moisture and high amount of water behind the tiles. Alongwith the plumbing wall, we also un-plastered the wall adjoining the balcony, that had no water connections and this wall also had traces of moisture. We could pinpoint no other source of water behind the tiles other than coming from the balcony adjoining the washroom. Upon inspection of the balcony we found out the floor grouting in between the tiles is old and had been damaged from a number of places from where there is high suspension that water could enter the slab be seeping into the subject room below the washroom adjoining the balcony. We also saw that skirting of the balcony is broken and parts are missing from a number of places. This could have very much resulted to water seeping into the slab and then into the ceiling of the level below this balcony.

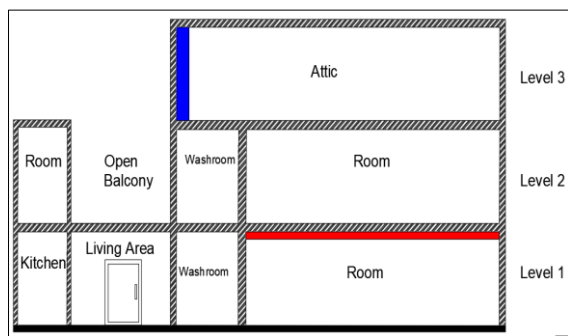
The next source of leakage can be seen expected on the top level. There is a large round window with an old wooden frame. This wooden frame is in direct contact with heavy rainfall as well as high temperature direct sunlight, due to which the frame of the window is severely damaged and rotten. Moreover, the glass pane of the window has a missing part, which, according to the owner, has been sent for repair and by virtue of huge tasks of maintenance, the owner has completely forgotten about return delivery and installation. The figure below is a diagrammatic representation of the area from where water could be coming into the attic and seeping into its flooring. The water could thereafter, be seeping into the wall of the room on level 2, from where it could be seeping into the slab between the rooms at level 1 and level 2.

Figure 6: The Attic Window

Next, there is a huge round window in this room which has a wooden frame. This wooden frame is completely spoiled due to presence of a lot of rain due to which there are large holes in this frame have been noticed. Moreover, a huge glass part of the pane is seen missing, which the owner says, broke a shattered a long time ago and has been sent for repair the previous year. This clearly means that this monsoon, there has been a large open window which has allowed all the rain water to enter the attic. We removed the whole wooden frame and replaced it with airtight, waterproof and insulated aluminium frame with acrylic pane, so as to make it stronger to bare the strong winds and rains.

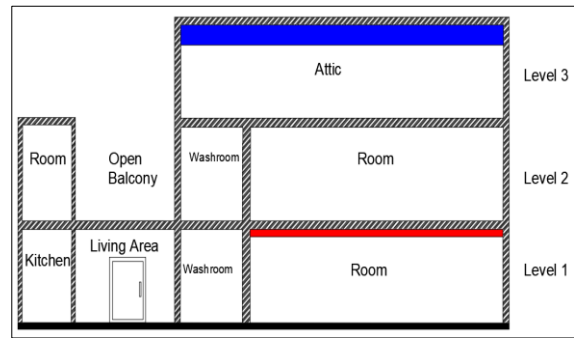
The attic has a slanting roof. This roof is very old and is made of slabs of terracotta. This terracotta, due to direct the engagement with a highest temperature from sunlight and also heavy rains in the monsoon could have developed cracks or could have broken due to which water maybe seeping into the shed flooring, from where it is going down to the level under it and seeping through the slab and going into level 1 so this is also a highly suspected source of leakage which has to be studied accordingly.

Figure 7: The Attic Slanting Roof

Another source of leakage that we understand is the slanting roof of the attic. As mentioned before, the slanting roof is made of material which has high water absorbing capacity, maybe slate or terracotta. The Slate slabs are also very old and marks of cracks the marks of damage and due to wear and tear of high temperatures from sunlight and heavy rainfall can be seen. This shed is one of the major sources of leakage in the whole penthouse. Therefore, we brought a team of masonry and re-built the whole attic.

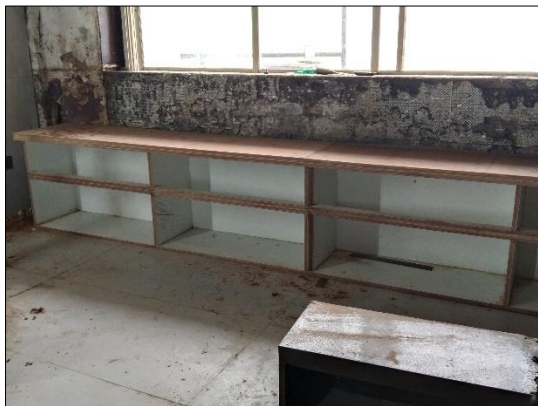
The photo below depicts severe water input from the window and it has damaged the wall structurally.

Figure 3: Condition of the Window Wall on Level 2

This majorly happened due to the fact that the window had no protruding covering or awning above it to restrict entry of rain entering the room. Figure 3 and Figure 4 depict permanent and temporary awnings respectively for usually installed at residential as well as commercial premises exposed to heavy rainfall in the city of Mumbai.

Since the water is entering from the window directly behind the furniture, it does not get a chance to dry or to be cleaned, so the water has been seeping into the room and there is huge probability that this water seeps into the slab between level 1 and level 2 and has been a primary reason of leakage in the room below.

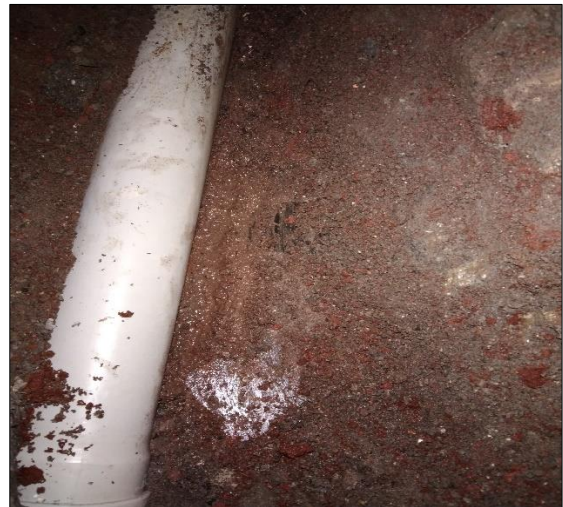
The second suspected source of water of leakage that is to be understood or research is the faulty plumbing in the bathroom at level 2. Once the washroom was unearthed, we found out that plumbing is faulty, has been done in a hurry and completely unprofessional. Thereafter we also saw that there is a lot of collection of water under these pipes, which means when the bathroom is being used regularly, the water is seeping from the pipes and collecting under the pipes on the slab.

Figure 5: Water near Underground Pipes

There is a high probability of this water to seep into the slab and thus entering the ceiling of the subject room.

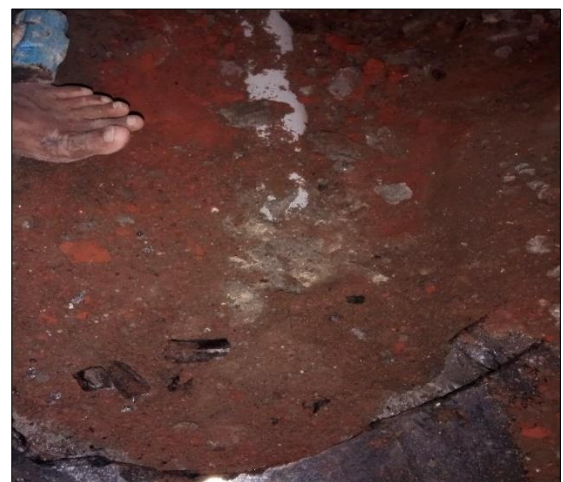
Other than the above, we also found that the waterproof membrane of the sunk slab has not been done properly. When we dug out the slab, we found loose sand and silt, the base made of bricks and cracks in the plaster as can be seen in the photo below.

Figure 5: Bricks used instead of Waterproof membrane

Bricks have high moisture absorbing capability and the absence of waterproof membrane has resulted into high amount of running water into the slab between Level 1 and Level 2.
