# Case Study: Leakage Issue in Residential Premises

Harjot Kaur

<sup>1</sup>Director, Harjot Kaur Décor LLP, MSc Mathematics, MBA Finance and Strategy  
300/1A&2, Rishabh Apartment, SK Bole Road, Mumbai, MH 400028  
Email: [harjotkaurdecor\[at\]0gmail.com](mailto:harjotkaurdecor[at]0gmail.com)

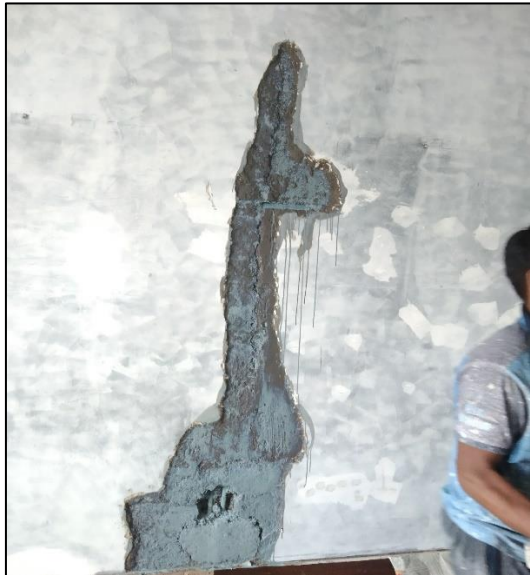
- 1) The internal wall marked in blue is the subject wall that was covered in moulds due to moisture from leakage/seepage.
- 2) The leakage in the wall was more at the base of the wall, while it reduced as it went towards the ceiling, i.e., leakage issue was less towards the ceiling and more expanded near the flooring.
- 3) A very peculiar finding made was that leakage and moisture collected more near the concealed switchboards in the den area (subject room) as well as in the Den's washroom.

Figure 1: Seepage near Concealed electrical wiring

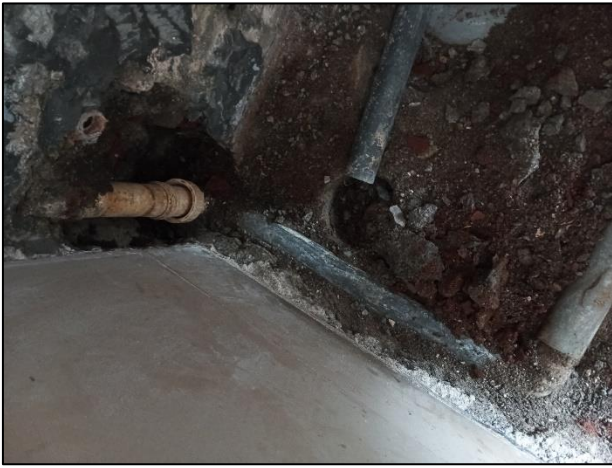
5) The next source of leakage could be the concealed pipes laid in the adjoining bathroom, which could be leaking. Now these pipes have not been checked, upgraded or repaired ever since the building has been constructed over 18-20 years ago. These pipes are said to be made of galvanised iron and could be rusted, due to which they could be leaking. This was one of the issues that could not be ruled out.

**Figure 4:** Rusted underground GI pipes

- 1) Break the bathroom flooring and inspect the concealed pipes and fittings for suspected leakages and upgrade all pipes and fixture to PVC from GI ones.
- 2) Remove the stone and plaster from the external bathroom walls and add a waterproofing membrane before putting tiles.
- 3) Cover and waterproof the complete duct area so no water enters the bathroom through the duct and the overhead bathroom area that protrudes and touches the duct from above.
- 4) Remove the plaster from the walls of the den and install waterproofing membrane and then repair the plaster and paint.

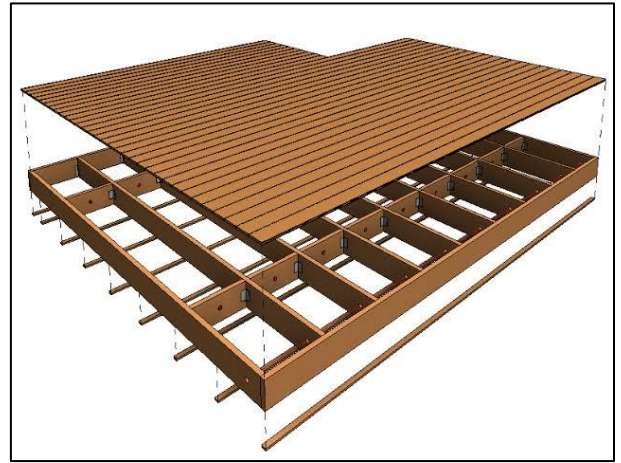
We hadn't initially seen what's under the wooden flooring, to understand how much and how fast the water travelled to the opposite wall. Upon inspecting through a hole which had termites, it was wet inside and we couldn't touch any kind of flooring nearby underneath. The white flooring we could see was atleast 2.5-3 inches deep. If the wooden flooring is thin, I suspect what's between the wooden flooring and the tile flooring could be a strong water soaking agent. Upon further inspection we discovered the wooden framed structure that was built to lay the wooden panels of flooring upon.

**Figure 5:** Framed Wooden Structure under wooden panelled flooring

The way to save that wall is to remove the wooden skirting and do grouting, which is waterproofing between the floor and the wall.

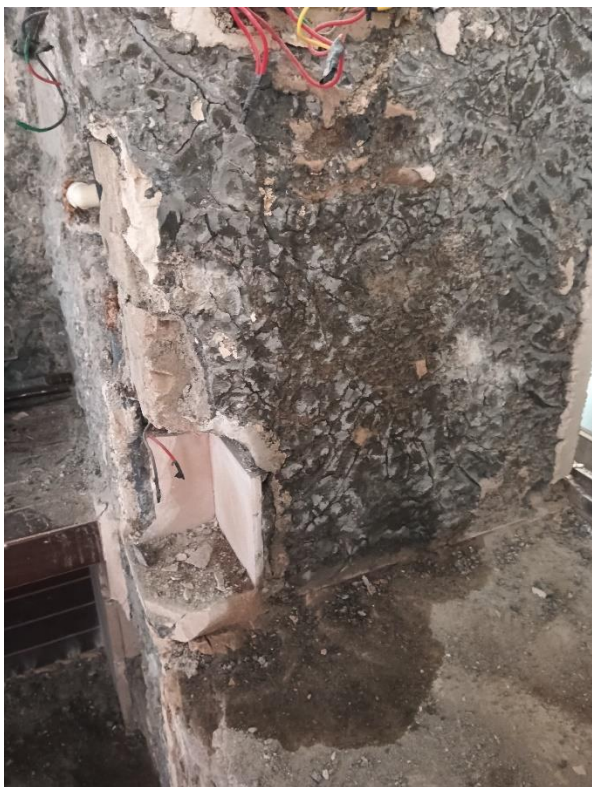
Secondly, when we removed the stone from the bathroom's walls that were adjacent to the duct, we noticed that the concealed wiring that connected the geyser and the switchboard has been concealed through and through by making a huge hole in the bathroom ceiling. This hole is in close proximity to the duct, which is open at the terrace and is susceptible to throwing water inside the bathroom ceiling. So the decision of partially covering the duct area with a slanting sheet of metal and sealing it with waterproofing chemical where it touches the wall was taken. Doing this prevents any water to fall on the overhead bathroom area where the geyser is placed and also rules out any water that would seep into the bathroom ceiling from the duct area.

**Figure 7:** Water Seeping into the concealed switchboard from the duct area
