Identification of Composite Insulator Failures in Service: A Utility Experience

Abstract: *High-voltage insulators are critical to the reliability of power transmission systems. This study explores the degradation issues of composite insulators and presents the implementation of Reliability-Centered Maintenance (RCM) at DEWA. Using advanced inspection tools such as UV and IR cameras, hydrophobicity tests, and laboratory analyses, the research identifies defects and outlines preventive strategies. The findings underscore the value of adopting RCM for early detection, enhancing reliability, and optimizing the economic lifespan of insulators.*

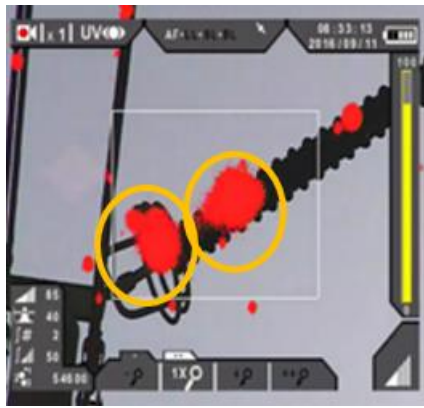
Figure 3: Defective Insulator with High Corona Discharge

Figure 3 depicts a photograph captured by the UV Corona Camera highlighting significant corona discharge activity (indicated in red). According to the EPRI guide, which is integrated into DEWA's quality procedures for overhead lines, this level of abnormality is categorised as "C". Referring to Table 1, this category requires action to replace or repair the metallic fittings of the insulator at the next available opportunity.

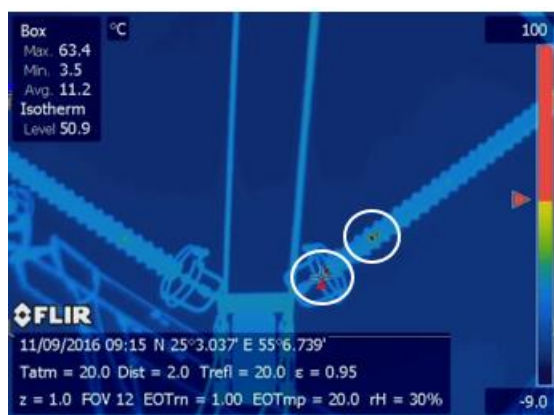
Following the identification, a subsequent inspection was conducted using an IR camera to ascertain the presence of hotspots at the same location of the defective insulator. Figure 4 reveals that a hotspot on the defective insulator was detected in a position analogous to the UV findings, specifically at sheds numbered 1 and 5 on the conductor side.

Figure 4: Defective insulator identified using IR Camera

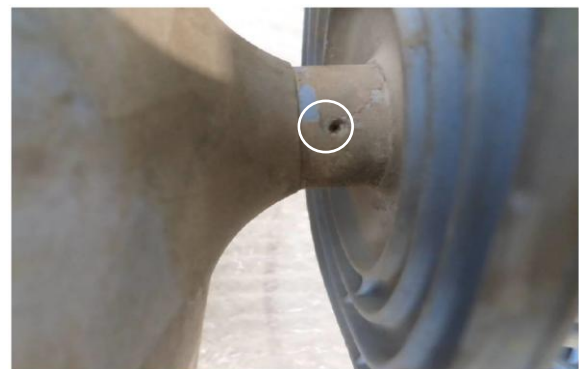
Based on the data presented in previous sections, an abnormality was identified on the insulator by both the UV & IR Cameras. Hence, it was verified through close inspection using the DSLR camera. Figure 5 illustrates damage in the form of a hole on the core rod housing of the insulator,

precisely matching the exact location pinpointed by both IR and UV inspections.

Figure 5: Defective insulator identified using DSLR Camera

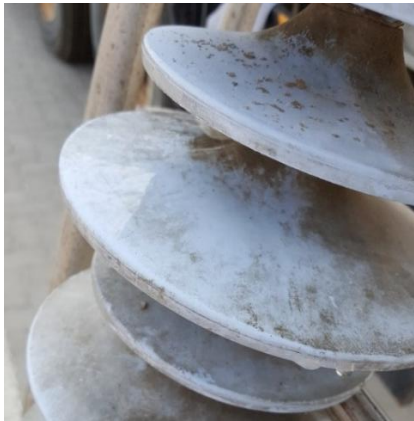
Figure 6: Hydrophobicity test on the surface of insulator

The results from the hydrophobicity test were compared to the six hydrophobic classes outlined in Figure 7, where HC1 denotes the most hydrophobic and HC6 the most hydrophilic in accordance with the IEC TS 62073 Standard [3]. Upon comparing Figures 6 and 7, it was evident that water droplets did not remain on the insulator surface, indicating a loss of hydrophobic properties. This categorises the defective insulator under HC6, signifying significant degradation of the insulator.

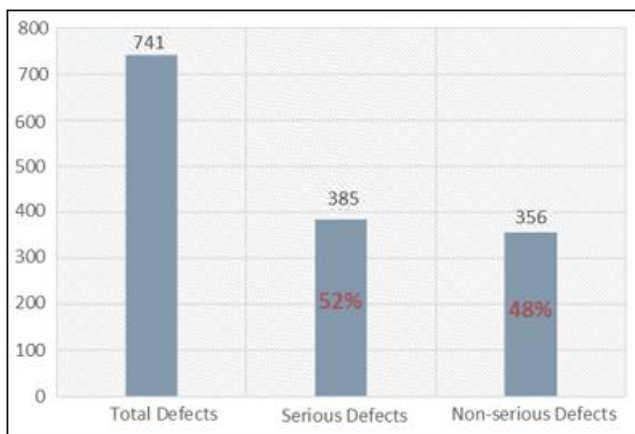
Figure 8: 400kV insulator defect statistics

All site inspection findings of the insulators collected from the UV camera, the IR camera, the DSLR camera and the hydrophobicity test were to be carefully analysed to establish the targeted condition assessment and then to formulate the appropriate rectification recommendations, such as replacement or surface soft cleaning. Furthermore, a database of insulator defects was established to comprehensively catalog all serious and non-serious defects as detailed in Table 2. This database presents a common brand type of 400kV long rod insulators installed from 2008 to 2009, highlighting significant identified defects. According to the statistics depicted in Figure 8, 52% of these defects were classified as serious.

Insulator	QTY	Commissioning Date	Expected lifetime (years)	Actual lifetime after defect identification (years)	No of identified Defects	No of serious defects
Brand A – batch 1	3505	2008	25	12	568	266
Brand A – batch 2	3564	2009	25	11	173	119
TOTAL	7069				741	385

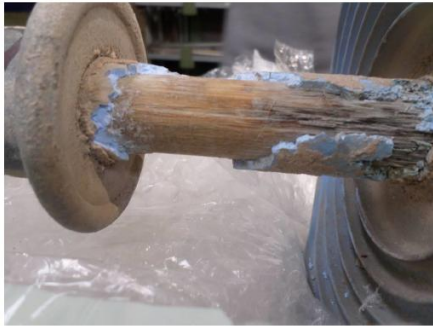
Visual inspection of Figures 9, 10 & 11 revealed damage to the housing of composite insulators, particularly affecting the fibre glass reinforced plastic (FRP) and sheds. The observed failures confirmed an abnormal, accelerated ageing process of the silicone rubber materials caused by severe electrical stress and erosion. Examination of the silicone rubber sheath on the FRP showed increased hardness, cracking, embrittlement, chalking, formation of holes and reduced mechanical properties.

Figure 9: Traces of electrical erosion

The third-party specialist conducted various adopted test procedures and concluded that the premature ageing of the insulators resulted from susceptibility to UV corona discharge, contamination, daily thermal cycles and high electrical stress.

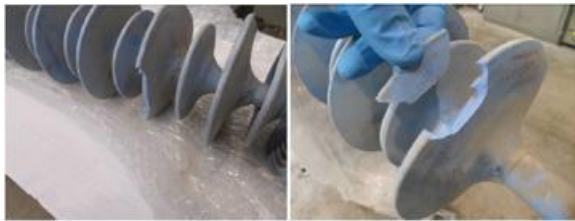
Figure 10: Ageing of middle and ground side sheds

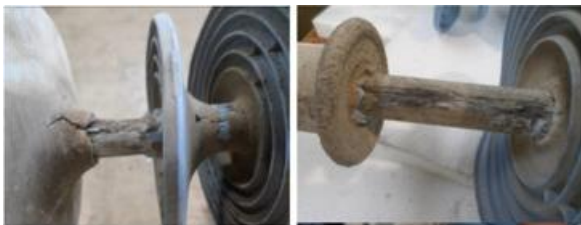
Figure 11: Silicon rubber FRP damages
