The Conservation State of the Gothic Alabaster Portal of the Parish Church of the Assumption of the Virgin Mary, Holy Cross and Bartholomew the Apostle in Drohobych

O.V. Rybchynskiy¹, O.V. Fomina²

^{1,2}Lviv Polytechnic National University, Department of Restoration of Architectural and Artistic Heritage
©O.V. Rybchynskiy, O.V. Fomina, 2018

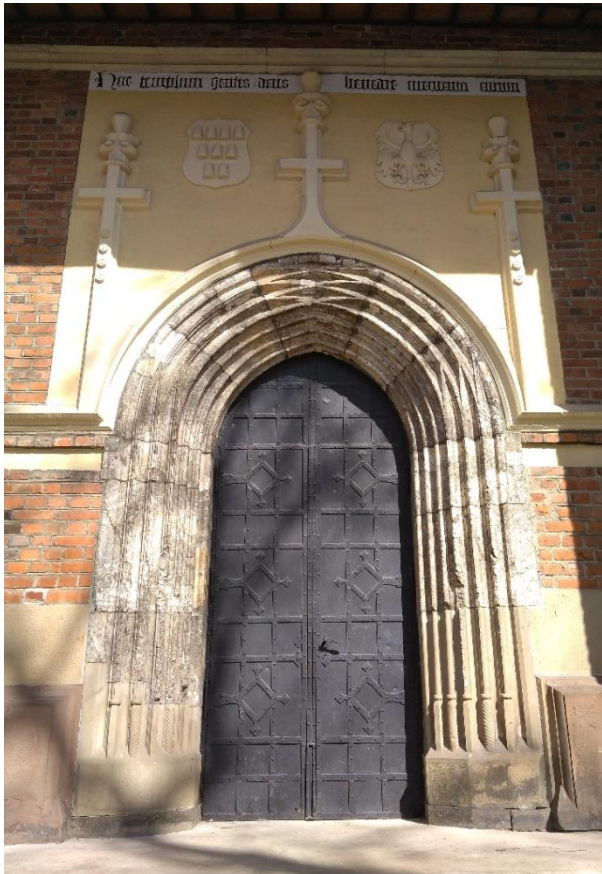
Figure 4: Drohobych, parish church, south portal, 2018

The gothic alabaster portal of the Church of St. Bartholomew in Drohobych is in the extremely unsatisfactory condition. Internal, small, large, deep cracks are visible all over the alabaster surface. Mechanical loading causes an increase in their size, depth and quantity. Rain, water, humidity, abrupt air temperature change leads to the formation of furrows, cavities, splits, weathering and stratification of the alabaster. Stratification can be mostly observed on the masonry wall of the church. The stone surface is uneven and loose, covered with black patina. There are also yellow, white and red-orange spots. Cracks, cavities, additions, masonry joints between the blocks, gaps are filled with cement mortar. The additions belong to different periods. A big gap across the plane between the portal jamb and the metal door is also filled with cement mortar. It indicates the fact that the entrance door was much closer. The additions of the jamb are partly green and black. There are also spots of red paint. Cement mortars used during the additions differ from each other by the ratio of binding agent and component composition: brick, sand, gypsum, lime. There are gypsum additions on the portal (gypsum without fillers, gypsum mixed with fibers, found between 7-8 blocks) and gauged mortar (the filler of which is crushed brick) in the joints between the blocks.

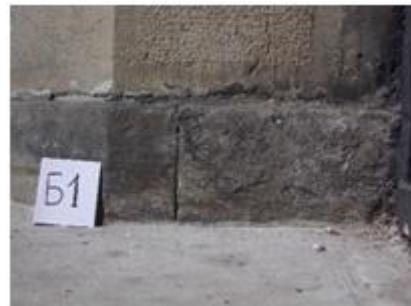
Block No. 1

State: stable

Losses: 90% of the face finish is lost

Deterioration: weathering, small splits

Cracks: two deep cracks, which can lead to chipping off the substantial part of the block

Contamination: black patina, yellow and white spots, which can cause dampness of the stone

Additions: joints between the blocks and the wall filled with cement mortar. One of the block planes is inserted as a separate slab, which can be a result of the previous restoration work.

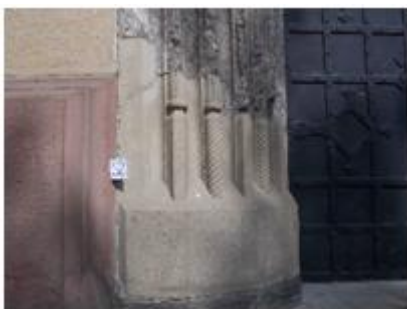
Block No. 2

State: satisfactory

Losses: not detected

Deterioration: stone weathering, small splits and cuts

Cracks: one large crack in the stone, which can lead to chipping off the substantial part of the block. The crack follows to the lower part of the block, jointed with cement mortar. Between the cement mortar additions and the stone small cracks appeared, one of which was jointed with cement over again.

Contamination: spots of black and red paint, little orange spots like spots of rust, white smudges

Additions: a gap between the block and the entrance door filled with cement mortar and partly painted in green colour.

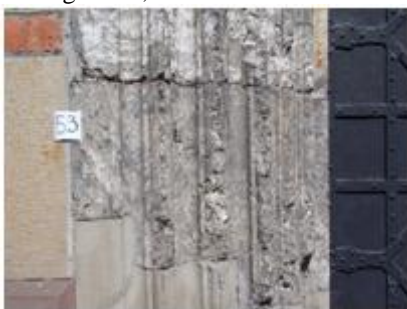
Block No. 3

State: unsatisfactory

Losses: lower part of the 1, 2, 3 ribs of the portal

Deterioration: on the most part of the stone's surface (80%) erosion caused by wind, water erosion, temperature change can be observed, which resulted into the formation of numerous cuts, cavities, splits, minor and large cracks. Marks of mechanical cleaning of the stone: deep even furrows all over the plane.

Cracks: minor, small, large

Contamination: yellow, red, white spots; spots of black and red paint

Additions: a gap between the block and the entrance door filled with cement mortar and partly painted in green colour. The joints between the blocks and the wall are filled with cement mortar.

Panels: jamb of the portal of yellow alabaster with grey veins

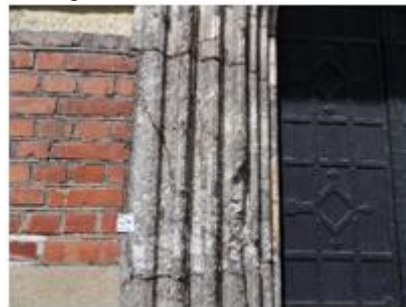
Block No. 4

State: unsatisfactory

Losses: significant part of portal ribs lost its initial form. A part of the third rib is completely lost.

Deterioration: on the most part of the stone's surface (80%) erosion caused by wind, water erosion, temperature change can be observed, which resulted into the formation of numerous cuts, cavities, splits, minor and large cracks. Marks of mechanical cleaning of the stone: deep even furrows all over the plane.

Cracks: two deep cracks, which can lead to chipping off the substantial part of the block; numerous small and internal cracks

Contamination: there are splashes of black and red paint on the internal side of the portal; green cement addition, black patina

Additions: 11 panels of yellow and grey alabaster. The state of panels is stable. Between the block and the entrance door there is a gap all over the height of the block filled with cement mortar.

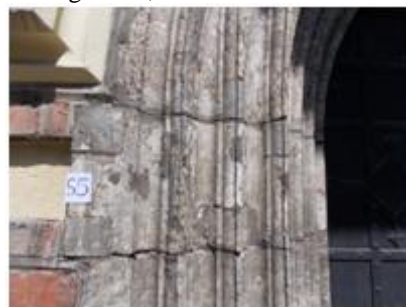
Block No. 5

State: unsatisfactory

Losses: a part of the yellow alabaster panel chipped off

Deterioration: erosion on the surface of the stone; the surface is uneven and rough, entirely covered with cavities, furrows; there are marks of coarse sandpapering of stone

Cracks: seven large deep cracks, which can lead to chipping off the substantial part of the block. Numerous minor, small and internal cracks.

Contamination: there are spots of black and red paint on the internal side of the portal; green cement addition, black patina

Additions: Six cement mortar additions. Between the block and the entrance door there are a gap, joints, cracks, cavities filled with cement mortar.

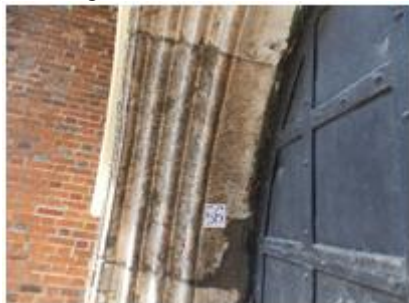
Block No. 6

State: unsatisfactory

Losses: part of the fifth molding

Deterioration: erosion of the surface of the stone, numerous cavities, cracks, furrows, and the surface is uneven and rough. There are flat horizontal furrows on the jamb of the portal. They are supposedly the marks of the tool, which remained after the stone dressing.

Contamination: there are spots of black and red paint on the internal side of the portal; green cement addition; black patina; yellow, white and orange spots; on the jamb surface of the portal lime or gypsum mortar was detected.

Additions: Between the block and the entrance door there are a gap, joints, cracks, cavities filled with cement mortar. Cement additions are also on the ribs of the portal.

Panels: five alabaster panels

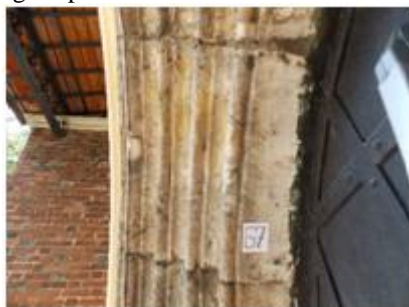
Block No. 7

State: unsatisfactory

Deterioration: mechanical deterioration – splits, erosion of the surface of the stone, numerous cavities, cracks, furrows

Cracks: three large cracks, which can lead to chipping off elements of the block

Contamination: most of the surface of the stone is covered with yellow spots, splashes of cement mortar; jamb of the block is rubbed with gypsum mortar

Panels: six alabaster panels of different colour

Additions: there is an addition of gypsum and cement mortar on the fourth rib. The crack on the third rib is filled with cement. Between the block and the entrance door there

is a gap all over the height of the block, joints between the blocks are filled with cement mortar. There is a sample of two kinds of cement mortar with different content of impurities between the seventh and the eighth blocks, which can be a result of the restoration work in different periods.

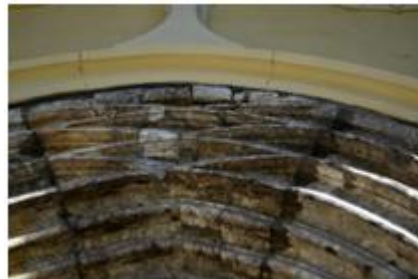
Block No. 8

State: unsatisfactory

Losses: part of the ribs at the intersection of the fourth row of ribs

Deterioration: mechanical deterioration – splits, erosion of the surface of the stone, numerous cavities, cracks, furrows; the stone is uneven and rough. There are deep furrows, which can be a result of the mechanical cleaning with metal brushes

Cracks: deep cracks between the alabaster panels and the authentic stone, deep crack on the second rib, which can lead to chipping off most of the block, numerous small cracks.

Contamination: splashes of cement mortar, yellow spots, black patina. Part of the cement additions between the block and the entrance door is in black, red and green paint.

Panels: ten alabaster panels of different colour – yellow, white, grey – fixed on the cement mortar. There is an inserted wood peg between the fifth and the sixth rib, polished as a profile shape.

Additions: cracks, joints between the blocks, a gap between the block and the entrance door filled with cement mortar.

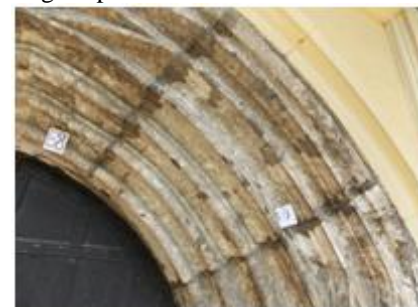
Block No. 9

State: stable

Losses: small piece of the sixth block is lost

Deterioration: deep flat furrows are cut horizontally on the jamb of the block in a chaotic order; there are also numerous furrows on the surface of the stone, which can be a consequence of the mechanical cleaning with metal brushes. Erosion of the surface of the stone, numerous cavities, cracks, furrows, and the stone is uneven and rough. The jamb of the block is far whiter than the natural colour of the stone, the reason of such state of the stone is unknown.

Cracks: four deep cracks, numerous minor and small cracks. There are also cracks in the cement addition between the block and the entrance door.

Contamination: yellow spots, black patina. A part of the cement additions between the block and the entrance door is in black, red and green colour.

Panels: three alabaster panels

Additions: numerous minor additions of cement mortar on the ribs of the block; also, on the entire surface near the junction of the eighth and the ninth block, between the jamb of the portal and the entrance door a gap is filled with cement mortar.

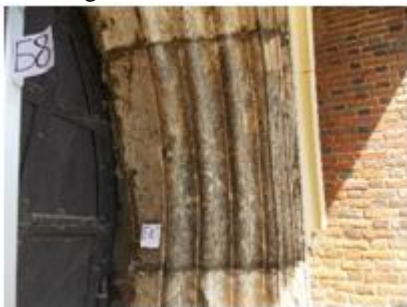
Block No. 10

State: stable

Deterioration: deep flat furrows are cut horizontally on the jamb of the block in a chaotic order; there are also numerous furrows on the surface of the stone, which can be a consequence of the mechanical cleaning with metal brushes. Erosion of the surface of the stone, numerous cavities, cracks, furrows

Cracks: seven large deep cracks (the biggest cracks are on the jamb of the block all over its height, as well as between the first and the second ribs over the block's height), numerous small and big cracks, which can lead to destruction and chipping off part of the block.

Contamination: yellow spots, black patina, a part of the cement additions between the block the entrance door is in black, red and green colour

Panels: four alabaster panels of different colour – yellow, green, white

Additions: cement additions on the ribs of the block near the junction of the eleventh and the tenth blocks over its breadth; all ribs in the lower part are supplemented with cement mortar, also a gap between the entrance door and the block; grouted joints and cracks. Cement additions fissure and come off the stone, cracks in the cement are filled with cement mortar again. There are as well cement mortars with different content of impurities.

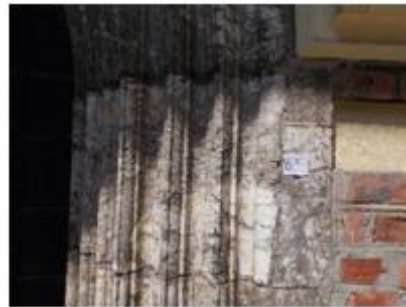
Block No. 11

State: unsatisfactory

Deterioration: stone stratification, mechanical damages, numerous splits, deep flat furrows are cut horizontally on the jamb of the block in a chaotic order, there are also numerous furrows on the surface of the stone, which can be a consequence of the mechanical cleaning with metal brushes. Erosion of the surface of the stone, numerous cavities, cracks, furrows

Cracks: six large deep cracks, which can lead to chipping off considerable part of the block. Numerous minor and small cracks.

Contamination: yellow spots, black patina, a part of the cement additions between the block the entrance door is in black, red and green colour

Panels: five alabaster panels of different colour – white, grey

Additions: three small cement additions on the ribs of the block, as well as between the entrance door and the block; grouted joints and cracks. Cement additions fissure and come off the stone, cracks in the cement are filled with cement mortar again. There are as well cement mortars with different content of impurities.

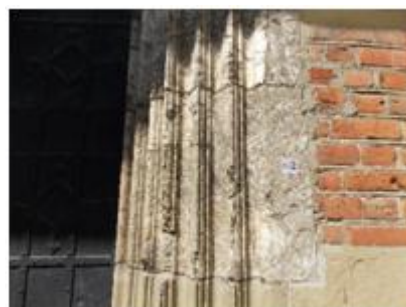
Block No. 12

State: unsatisfactory

Losses: considerable part of the fourth rib of the block is lost. A part of the ruined block (the fourth one) was supplemented with the alabaster panel, which is lost as well. There are preserved marks of panel mounting: four hewn rectangular chamfers and cement mortar on which the panel was fixed. A little fragment of the third block is lost too.

Deterioration: stone stratification, mechanical damages, numerous splits, deep flat furrows are cut horizontally on the jamb of the block in a chaotic order, there are also numerous furrows on the surface of the stone, which can be a consequence of the mechanical cleaning with metal brushes. Erosion of the surface of the stone, numerous cavities, cracks, furrows

Cracks: four deep cracks, the biggest one is on the jamb of the block and follows all over its height

Contamination: yellow spots, splashes of green and red paint, a part of the cement additions between the block and the entrance door is in red, green and black colour.

Panels: four alabaster panels of different colour – grey and white

Additions: a gap between the entrance door and the block, joints between the blocks, cracks and splits are filled with cement mortar.

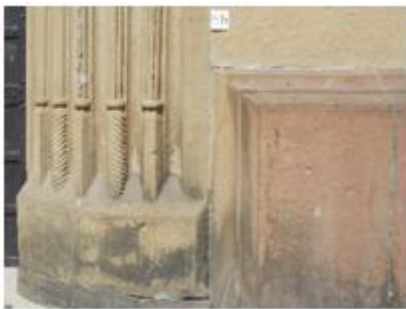
Block No. 13

State: satisfactory

Deterioration: small splits and cavities

Cracks: one crack between the cement addition and the stone

Contamination: black patina, splashes of black and red paint, cement mortar on the rib of the profile. Small spots of orange and red colour, which resemble the spots of rust. The yellow and white spots caused the dampness of the stone. Cement additions are in green colour.

Additions: a gap between the block and the entrance door all over the height of the block filled with cement mortar; grouted joints, cracks, cavities. Cement additions fissure and come off the stone.

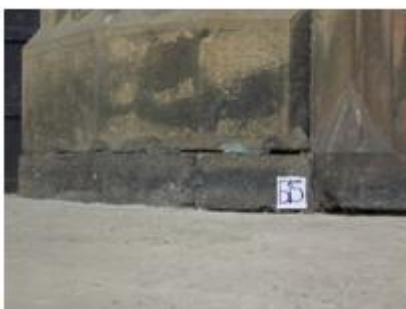
Block No. 14

State: satisfactory

Losses: decorated surface finish of plinth is partly lost

Deterioration: one of the plates comes off the plinth; small splits; weathering of the stone, yellow and white spots.

Contamination: black patina

Additions: a gap between the block and the entrance door all over the height of the block filled with cement mortar; grouted joints, cracks, cavities.

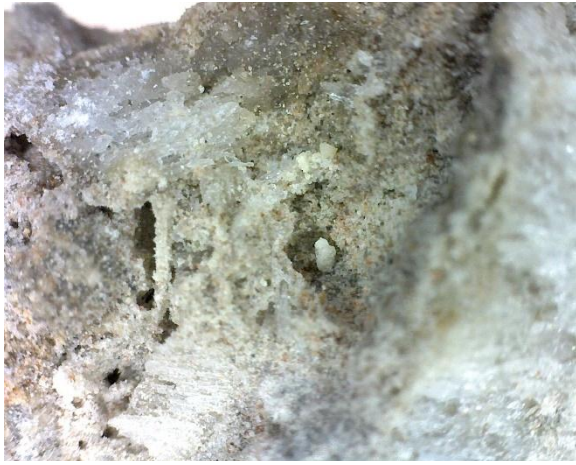
Figure 5: Block 11. Sample XV. Clearly outlined structure of the alabaster crystals. Finely crystalline structure. Small content of clay impurities and veins of fibrous selenite

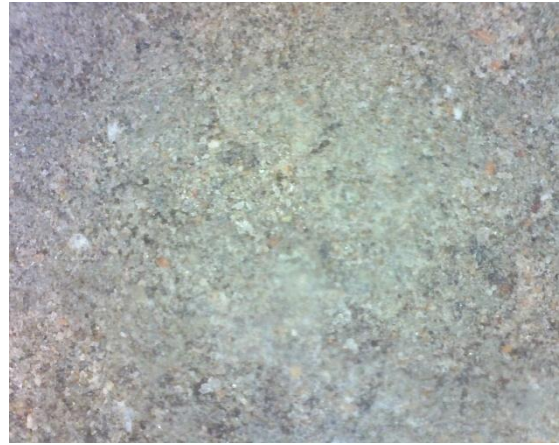
The cement mortars differ from each other by the ratio of binding agent and component composition: brick, sand, gypsum, lime (Figures 7-8).

Figure 8: Block 1-2. Sample XIX. Impurities of brick powder and lime

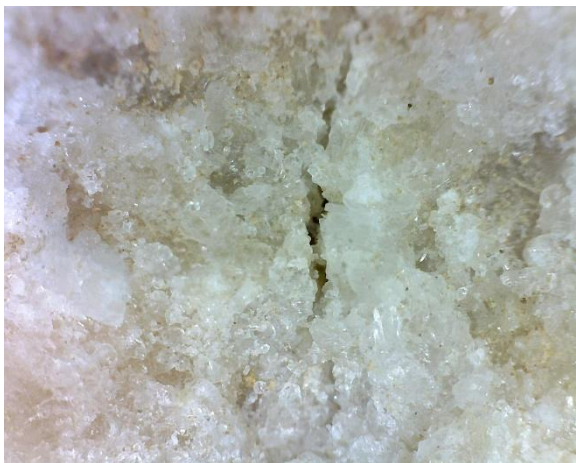
Figure 6: Block 7. Sample XI. The process of water erosion and void formation was observed, which caused the cracks in the stone

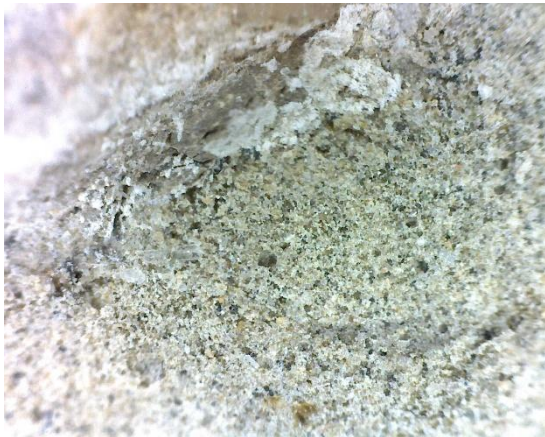
Figure 7: Block 6. Sample IX. Lime and sand content is bigger than cement content. Mortar structure is porish
