To Reduce Timer Plate Leakage in VE-Mechanical Pumps Using SPC Techniques

Abstract: Six sigma methodologies DMAIC is very important statical process control technique regarding process improvement, control and productivity improvement in manufacturing industries. In an existing manufacturing process DMAIC, Root cause analysis and ISHIKAWA diagrams are powerful techniques to find out the actual causes which are reducing the productivity. During scrutiny of assembly process of VE- pumps critical parameters, which have major impact on productivity and quality were identified by using ISHIKAWA diagram and actual causes of leakage were resolved by root cause analysis. Thus process can be improved and controlled on the basis of SPC techniques. This paper focusing on the DMAIC technique used to improving the existing handing method at BOSCH, Jaipur plant in the assembly of VE-fuel injection pumps. This paper also integrates with implantation of six sigma to define the maximum safe no. of cycles for test timer plates-312.

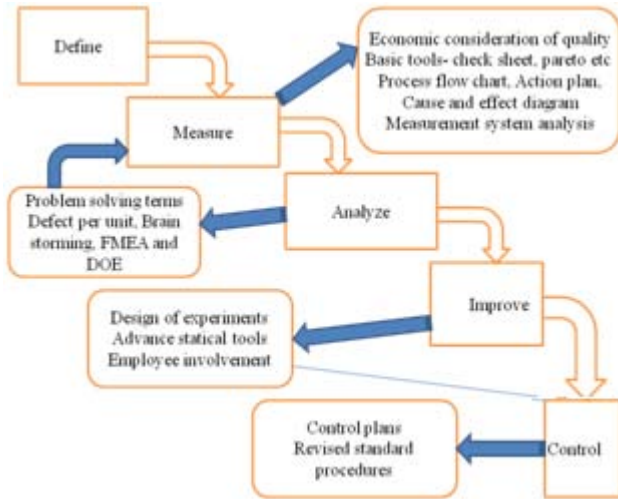
Figure: Flow of DMAIC

- Defining the process or problem that forms the focus of the project.
- Measuring the key variables that drive process performance in order to find leverage points for Improvement.
- Analyzing the data to test hypothetical solution variables.
- Making improvements based on analysis and experimentation, and rolling the improved processes out on a large scale and implementing process management systems, both to hold the gains and identify further opportunities for improvement.
- Than control the system.

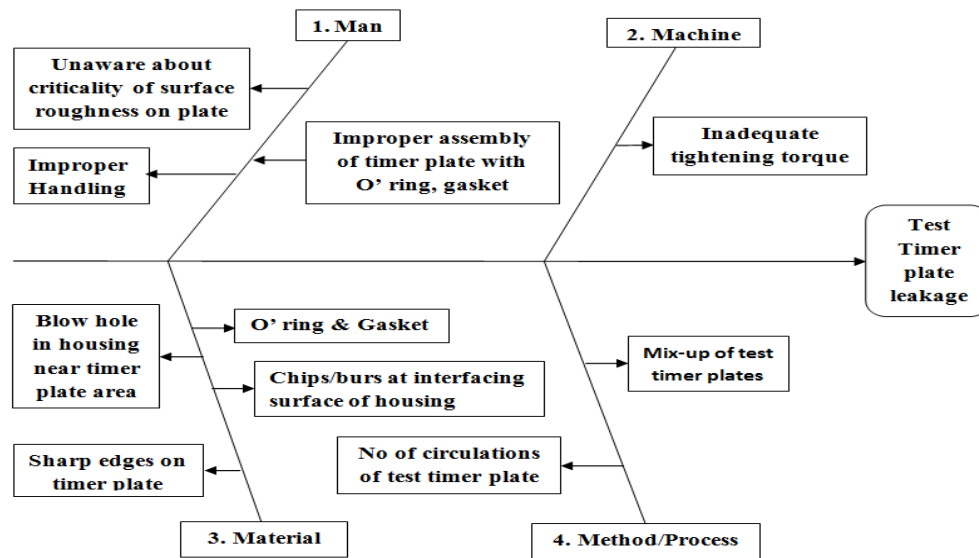
Figure: ISHIKAWA diagram

Ishikawa diagram also called fishbone diagrams, cause-and-effect diagrams, are casual diagrams created by Kaoru Ishikawa (1968). The common uses of the Ishikawa diagram are product design & quality defect prevention, and to identify potential factors causing an overall effect. Considering people, machine, material and methods a fishbone diagram is drawn for timer plate leakage as shown in below figure.

Thus causes are usually grouped into major six categories, which are sources of variation. These categories include-

- **People:** Associates involved with the process.
- **Methods:** How process is being performed and specific requirements for it, such as procedures, rules etc.
- **Machines:** Equipment, tools and machines etc. required to accomplish the job.
- **Materials:** Raw materials- different parts, pencil, tools, oil etc. used to produce the final product.
- **Measurements:** Data generated from the process that are used to evaluate its quality like- production rate, percentage rejection etc.
- **Environment:** The conditions such as, time, temperature and culture in which the process is being operates.

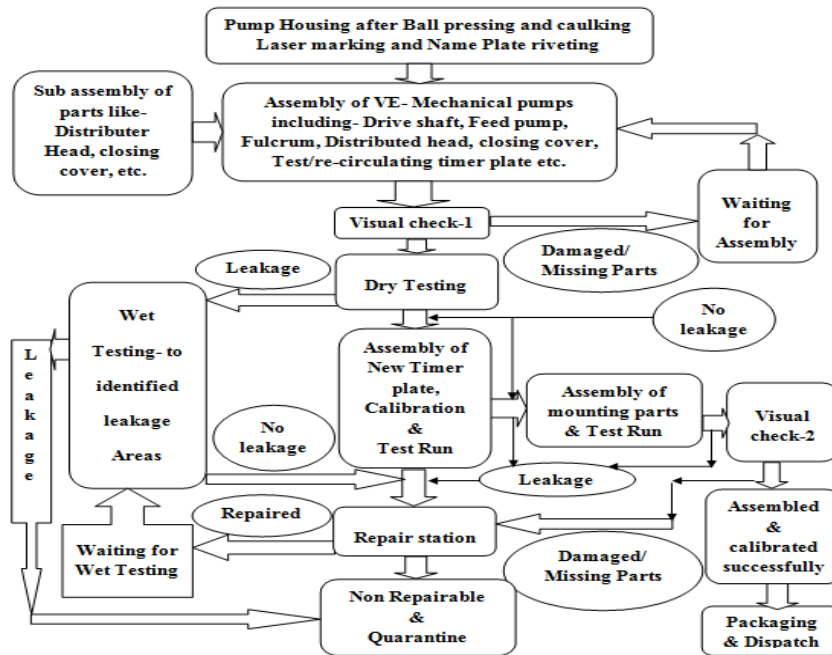
Figure: Process flow chart

The process flow of VE- pumps started with Assembly of VE-mechanical pump along with sub-assemblies of distributor head, closing cover, etc. After assembly, it proceeds through Dry testing for tightness, Visual checking-1, Wet testing to find the leakage areas, Calibration for setting delivery of fuel (diesel) at different RPMs, Post-Calibration for assembly of Mounting parts & Test Run and Visual checking-2 for correct assembly and then packing & dispatching to the customers. To overcome the reduced production of pumps two repair stations are established for repairing the rejected/failed pumps during testing for leakage proofing. The sequential flow of all processes is shown in below flow chart.

Step-1: After complete assembly, pump is first checked at visual testing station for all parts as per drawing.

Step-2: In dry testing- pump is tested for leakage proofing at a rate of two pumps per 1.2 minutes.

Step-3: At calibration station VE-mechanical pumps are checked for leakage by the way of setting the delivery values at different load and rpm.

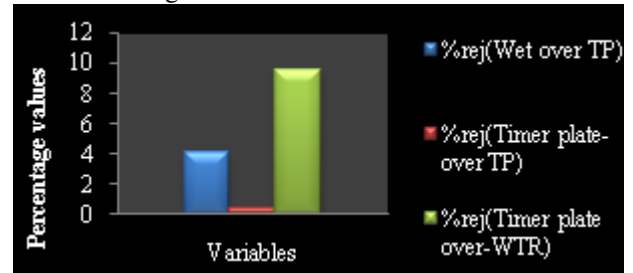
Pareto: Percentage contribution

No of Days	Production per day	No of rejections according to type of leakage areas/joints							
		Leakage testing (Dry)	Leakage testing (Wet)	Timer plate leakage	Shoulder Screw Leakage	Outlet / Inlet tube leakage	Fitting leakage	Closing cover/LDA leakage	Blow hole & other leakage
1	1064	98	48	5	6	3	4	2	28
2	1161	87	57	4	4	2	3	3	41
3	1166	90	60	5	5	4	4	2	40
4	1187	84	48	4	4	4	3	2	31
5	1139	92	54	4	5	3	2	1	39
6	1110	96	45	5	3	3	3	3	28
7	1167	74	38	4	4	5	2	1	22
8	1241	78	39	4	4	2	2	2	25
9	1284	68	51	5	3	4	2	4	33
10	1260	70	41	5	4	3	4	3	22
Total	11779	837	481	45	42	33	29	23	309
Avg.	1178	84	48	5	4	3	3	2	31
% over avg. prod. per day		7.13%	4.07%	0.42%	0.34%	0.25%	0.25%	0.17%	2.63%

After collecting the rejection data with process flow study in detail, it is observed that for leakage proofing all VE-pumps passes through different testing stages- visual check, post calibration, calibration, dry testing and wet testing. After data analysis problem is identified as the maximum rejection of VE-mechanical pumps is due to leakage at timer plate type-312, which contributes to 0.38% over per day average production and 9.5% over average rejection at the Wet testing stage.

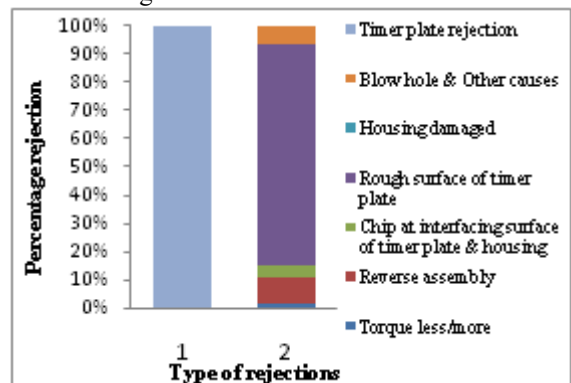
Pareto: Percentage contribution

No of Days	TPR	No of timer plate rejections based on different causes					
		Torque less/more	Reverse assembly	Chip at interfacing surface of timer plate & housing	Rough surface of timer plate	Damaged Housing	Blow hole & Other causes
1	5	0	1	0	4	0	0
2	4	0	0	0	3	0	1
3	5	0	0	0	4	0	1
4	4	0	1	0	3	0	0
5	4	0	0	1	3	0	0
6	5	1	0	0	4	0	0
7	4	0	0	1	2	0	1
8	4	0	0	0	4	0	0
9	5	0	1	0	4	0	0
10	5	0	1	0	4	0	0
Total	45	1	4	2	35	0	3
% over TPR		2.20%	8.90%	4.40%	77.80%	0.0%	6.70%

Problem- Timer plate leakage due to greater rough surface, 3 to 4 cases were observed daily.

1. Associates are unaware about criticality of surface roughness on timer plates and process.
2. Plates are being used more than defined no. of cycles.
3. Improper handling method at calibration station, which increases the roughness rapidly.

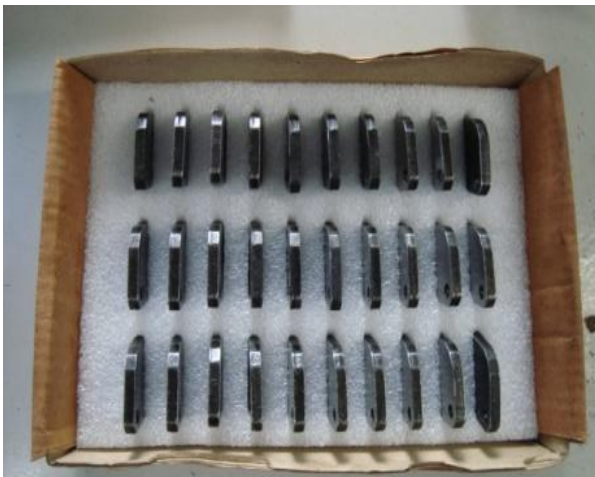
Figure: Timer plates within thermocal seat

1. Associates to be made aware about the criticality of surface roughness on timer plates and process.
2. Proper surface finishing should be done after pre define no. of cycles. So that assembly of improper timer plates will be eliminated.
3. New handling method- use the tray with thermocal seat, having holes for inserting timer plates separately. So that plates will not strike each other and thus dents will not developed on surface of the timer plate as shown in below figure.
4. Regrinding should be done after pre define optimum no. of cycles i.e. sixty days.

Step-1: Paste a list having “starting date and bin no-1, 2, 3....etc. on every storage bin.

Step-3: Circulate the bins in a proper sequence- starting with bin-1 at assembly station-5 and use the plates from the same until it becomes empty completely.

Step-5: After disassembly (station -42) operator must insert all the timer plates into thermocal sheet within the storage bin.

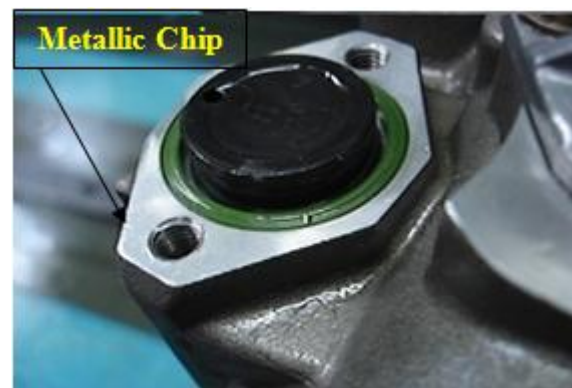
Figure: Chip at interfacing surface of housing and plate

- Metallic chips were found at interface surface of housing & timer plate as shown in below figure.

- Cleaning at interfacing surface should be done by vacuum cleaner in place of pressurized cleaning because former method is more effective than the later.

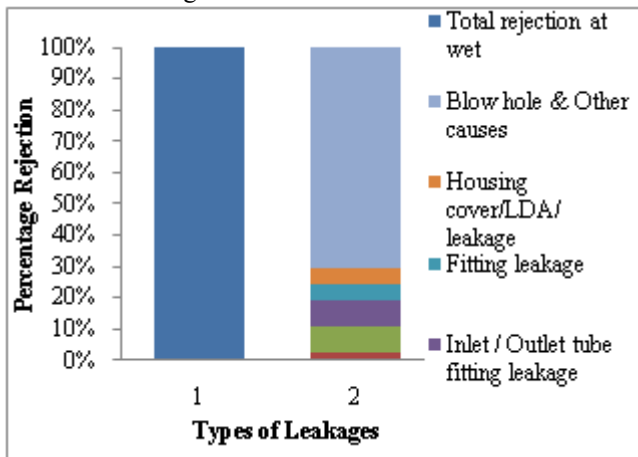
Pareto: Percentage contribution over WTR

No. of days	Prod ⁿ per day	No. of pumps rejected according to types of leakage areas/joints						
		Total rejections (wet)	Timer plate leakage	Shoulder Screw Leakage	Inlet / Outlet tube fitting leakage	Fitting leakage	Housing cover/LDA/ leakage	Blow hole & Other causes
1	1126	38	1	5	3	2	2	25
2	1086	42	0	4	2	1	2	33
3	1052	38	1	2	4	2	3	26
4	1128	35	0	3	4	2	1	25
5	1022	36	2	4	5	3	2	20
6	1108	34	1	4	3	2	3	21
7	1188	39	0	3	2	4	2	28
8	1098	32	1	2	4	2	3	20
9	1190	44	0	3	2	3	1	35
10	1127	37	0	2	2	1	2	30
Total	11125	375	6	32	31	22	21	263
Avg.	1113	38	1	3	3	2	2	26
Percentage over Avg. PP		3.41%	0.09%	0.27%	0.27%	0.18%	0.18%	2.34%

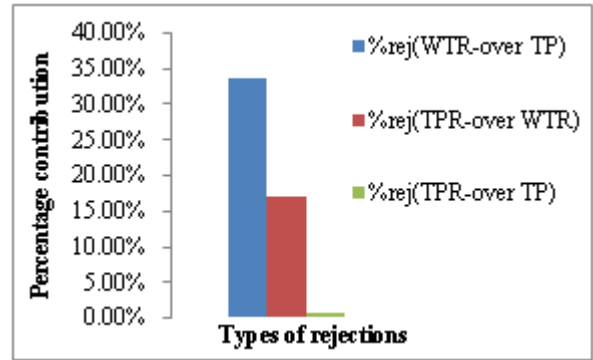
Pareto: Percentage contribution of TPR over WTR and TP

No. of Days	Production per day	WTR	TPR	%rej(WTR-over PP)	%rej(TPR-over PP)	%rej(TPR-over WTR)
1	1126	38	1	3.37	0.09	2.63
2	1086	42	0	3.87	0	0
3	1052	38	1	3.61	0.1	2.63
4	1128	35	0	3.1	0	0
5	1022	36	2	3.52	0.2	5.56
6	1108	34	1	3.07	0.09	2.94
7	1188	39	0	3.28	0	0
8	1098	32	1	2.91	0.09	3.13
9	1190	44	0	3.7	0	0
10	1127	37	0	3.28	0	0
Total percentage				33.71%	0.57%	16.89%

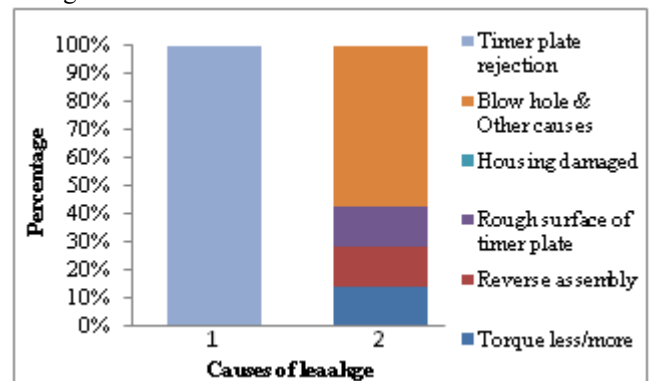
Pareto: Percentage contribution of different causes of leakage over TPR

No. of Days	Timer plate rejection	No. of timer plate rejections according to different causes					
		Torque less/more	Reverse/Wrong assembly	Chip at interfacing surface of timer plate & housing	Rough surface of timer plate	Housing damage	Blow hole & Other causes
1	1	0	0	0	0	0	1
2	0	0	0	0	0	0	0
3	1	0	0	0	0	0	1
4	0	0	0	0	0	0	0
5	2	0	0	0	1	0	1
6	1	0	0	0	0	0	1
7	0	0	0	0	0	0	0
8	1	0	1	0	0	0	0
9	0	0	0	0	0	0	0
10	0	0	0	0	0	0	0
Total	6	0	1	0	1	0	4

1. At first day one rejection was found as less torque which was due to damaged thread inside the hole at pump's housing (added in blow holes & other causes).
2. On eighth day of scrutiny one rejection was found as assembly of wrong timer plate (type-307), which was a mixed up case of timer plates.
3. On fifth day one rejection was found due to rough surface on timer plate which was due to either improper handling of timer plate or other. The exact reason was unknown to me. Thus this timer plate was replaced with new plate.
4. During ten days of scrutiny four causes were found as-blow holes in the pump's housing that were manufacturing defects and can't be reduced here.

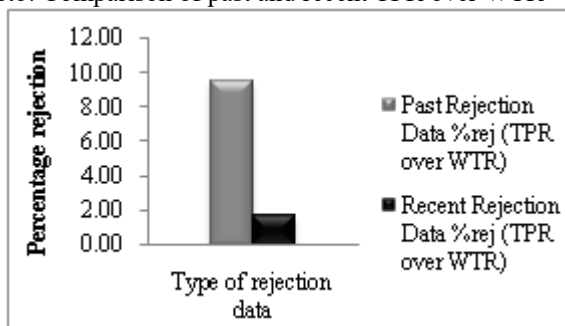
Pareto: Comparison of past and recent TPR over WTR

Sr no.	Past Rejection Data		Recent Rejection Data	
	%rej (TPR over WTR)	%rej (TPR over PP)	%rej (TPR over WTR)	%rej (TPR over PP)
1	10.42	0.47	2.63	0.09
2	7.02	0.34	0	0
3	8.33	0.43	2.63	0.1
4	8.33	0.34	0	0
5	7.41	0.35	5.56	0.2
6	11.11	0.45	2.94	0.09
7	10.53	0.34	0	0
8	10.26	0.32	3.13	0.09
9	9.8	0.39	0	0
10	12.2	0.4	0	0
Avg.	9.54	0.38	1.69	0.057

In the above analysis, the maximum rejections of VE-mechanical pumps were found as timer plate leakage. For timer plate leakage five major causes were found as surface roughness, torque less/ more, metallic chip found between interfacing surfaces of plate & pump housing, reverse assembly and damaged housing. The major cause is rapid increase in surface roughness on the plates, which is due to improper handling of plates at calibration station. After deep investigation this research suggests a proper handling method for timer plates. According to the suggested method timer plates are being inserted into a bin having a thermal sheet. After implementing the given suggestions it was observed that due to timer plate leakage percentage rejection of VE pump is reduced from 0.38% to 0.057% over total production and wet tightness rejection reduced from 9.7% to 1.69% over wet testing rejection.
