Occlusion Guided Immediate Single Complete Denture Repair: A Case Report

Abstract: In day to day dental practice single complete denture fracture is often seen condition. Denture repair is possible using conventional methods when broken fragments can be aligned in its actual position. But in conditions where one of the broken denture fragments is missing and denture cannot be aligned, using occlusion as a guide for repair can be done as explained.

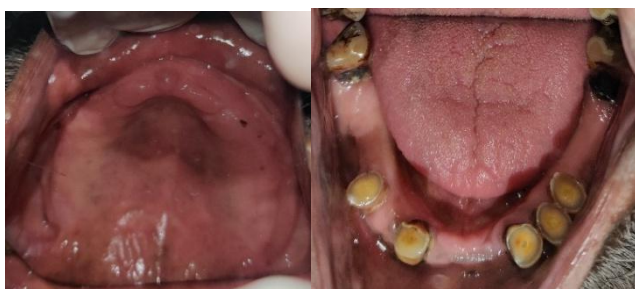
Figure 1 Figure 2

- 1) Maxillary arch was completely edentulous. (Fig. 1)
- 2) Mandibular arch was partially edentulous with generalised gingival recession and attrition. Number of teeth missing i.r.t. 31,32,36,37,41,42,44,46,47. Grade II mobility was seen i.r.t. 33 and 35. (Fig. 2)

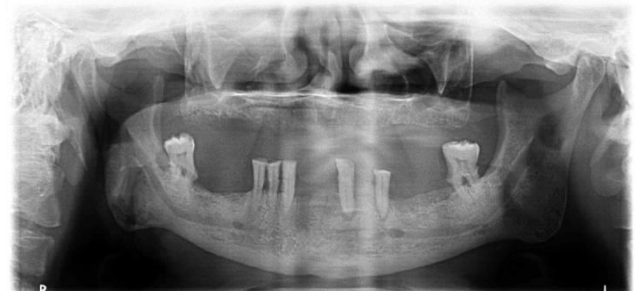
Figure 3

- 1) Ridge resorption in maxilla.
- 2) Horizontal bone loss i.r.t 33, 35, 38, 43, 44, 45, 48.
- 3) Furcation involvement i.r.t 38, 48.
- 4) Periapical radiolucency i.r.t 33. (Fig. 3)

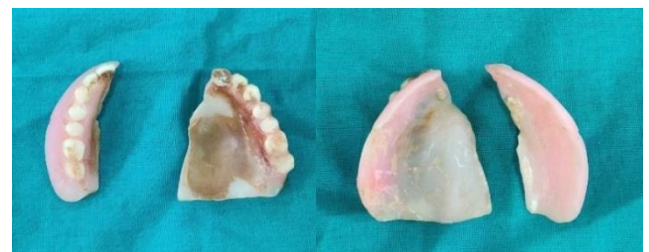
Figure 4 Figure 5

After examination of broken maxillary complete denture, which was in two pieces, when tried to realign the denture, it was noticed that one fragment was missing. (Fig. 4, 5)

Since fracture line was not merging and one fragment was missing from the denture, it was difficult to realign and stabilize the denture. That's why impression of mandibular arch was made with dentulous perforated metal stock tray using Alginate (Dentsply). Impression was poured with Type III gypsum material (Kalabhai). Cast was retrieved after material had set. (Fig. 6, 7)

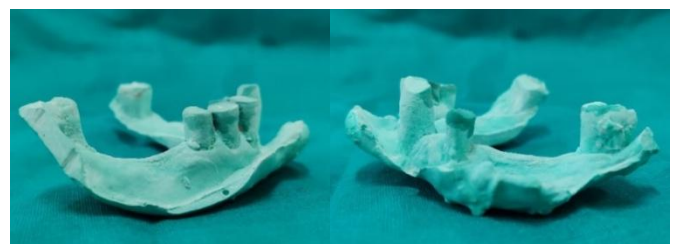
Figure 6 Figure 7

*Note: base was not poured intentionally to get access to the fracture line from polished surface.

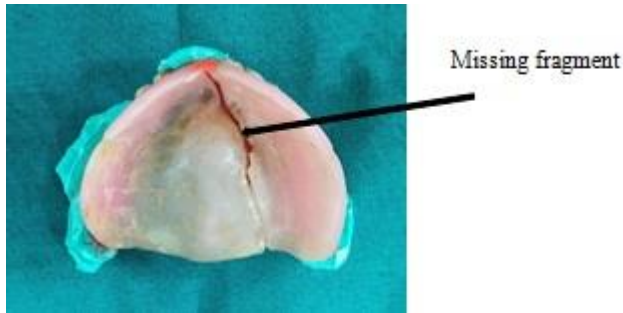
Figure 8

Denture pieces were tried to align one by one according to occlusion. (Fig. 8)

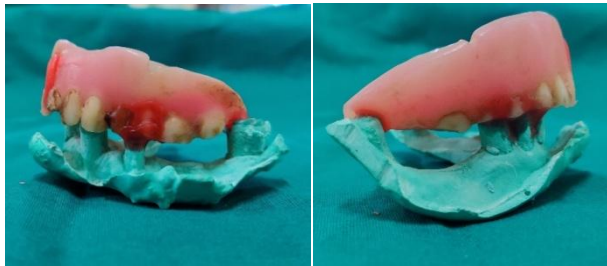
Figure 9 Figure 10

Once the teeth got occluded properly both the pieces were sealed to lower cast using modelling wax (Pyrex).(Fig. 9, 10)

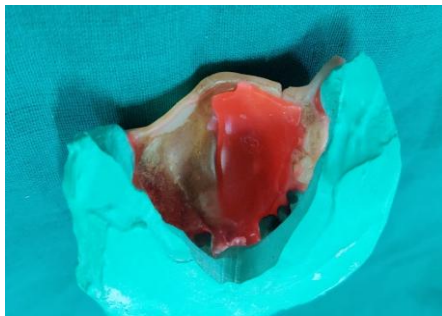
Figure 11

Once the denture got stabilized a single layer of modelling wax sheet (Pyrex) was adapted on the polished (palatal) surface of denture throughout the fracture line to support repair acrylic resin material. Wax layer was sealed at the peripheries. (Fig. 11)

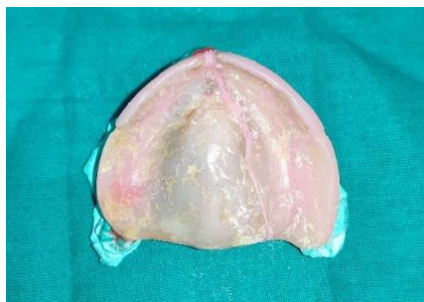
Figure 12

Self-cure pink acrylic resin power and liquid (DPI) were mixed according to polymer and monomer ratio. In dough stage material was packed in fracture line area and removal of excess material was done. (Fig. 12)

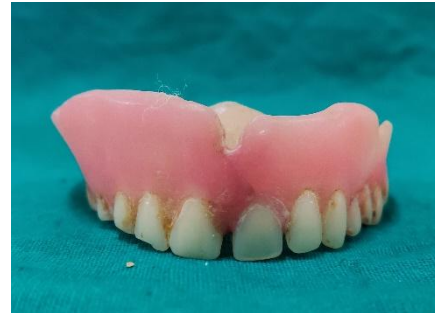
Figure 13

Once the material had polymerized, the wax layer from the polished (palatal) surface was removed and denture was separated from the opposing mandibular cast. After separation damaged upper left central incisor was replaced from the denture base using acrylic denture tooth. (Fig. 13)

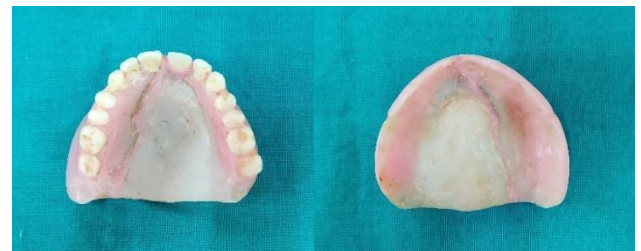
Figure 14 Figure 15

Finishing and polishing was done.¹ (Fig. 14, 15)

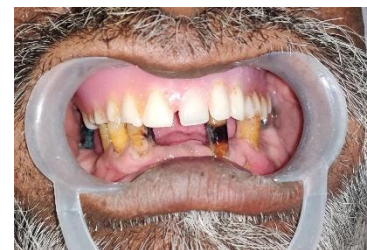
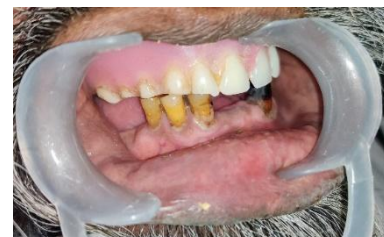
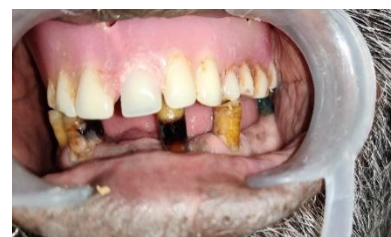
Repaired maxillary denture was inserted in patient's mouth and occlusion was checked. (Fig. 16, 17, 18)

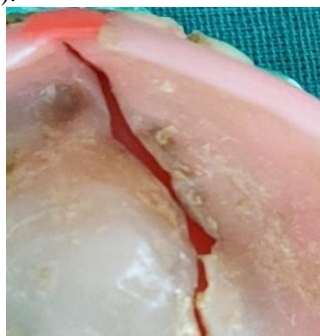
Figure 19

Now patient wanted denture to be repaired, as patient was in hurry, he wanted an immediate denture repair. So, we decided to do so. But when we tried to align the denture, we noticed that one small fragment was missing from the denture (Fig. 19).

That's why the technique we decided to use occlusion as guide for single complete denture alignment for its repair (Manual Maxillomandibular fixation technique)⁵ to repair as explained above.
