Value of Contrast Enhanced CT in Detecting Active Haemorrhage in Patients with Blunt Abdominal or Pelvic Trauma

Abstract: *Objectives-To evaluate the use of contrast enhanced CT to show sites of active haemorrhage as a guide for surgical or angiographic treatment in patients sustaining blunt abdominal or pelvic trauma. Place-Department of Radiodiagnosis, MGIMS Sevagram. Materials and methods-25 CT scans were reviewed to compare the location of extravasated contrast material (haemorrhage) detected on CT with the sites of active haemorrhage determined by surgery (fifteen) and angiography (five). The five remaining patients had no additional study done. The attenuation of extravasated contrast on CT was compared with CT attenuation of adjacent artery. Attenuation of clotted blood within the abdomen or pelvis was also measured. Results-The location of extravasation of contrast material as shown on CT scan included the spleen (seven), pelvis (six), retroperitoneum (four), kidney (four), liver (two) and adrenal gland (one). One patient had venous extravasation. The origin of bleeding was confirmed in all cases to correspond to the anatomic region of extravasated contrast on CT. The CT a

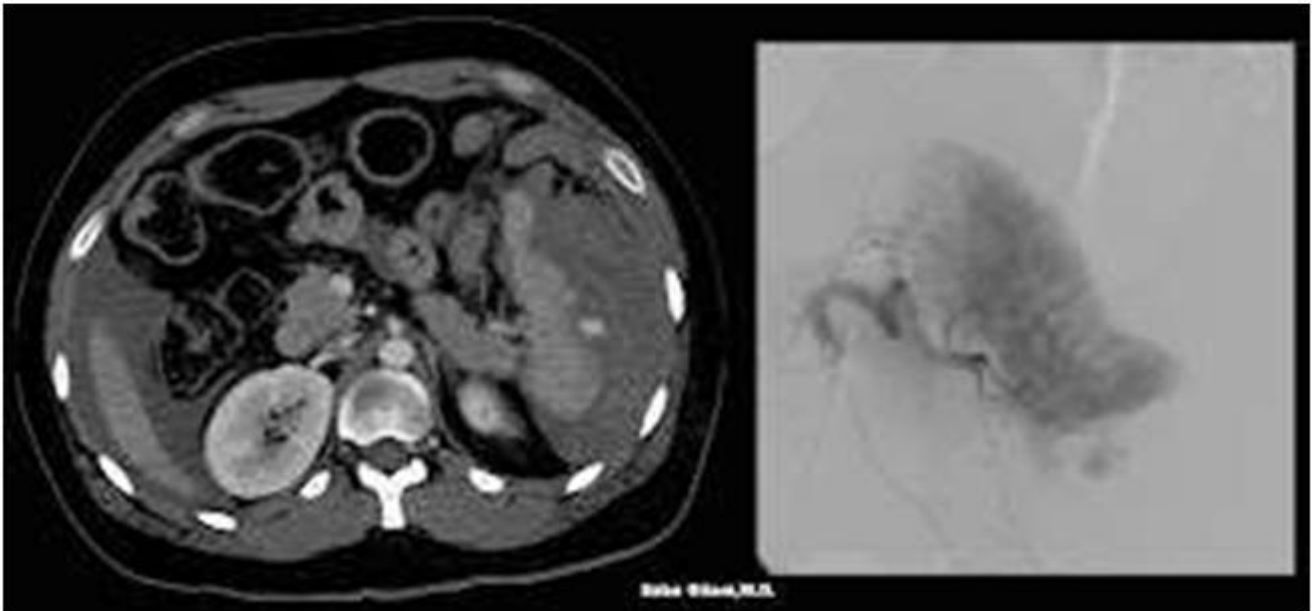
- The above CECT demonstrates a large subcapsular splenic hematoma causing compression and medial deviation of the spleen. A focus of high density within this hematoma represents active contrast extravasation.
- Angiogram of the splenic artery shows a blush of contrast near the inferior splenic pole

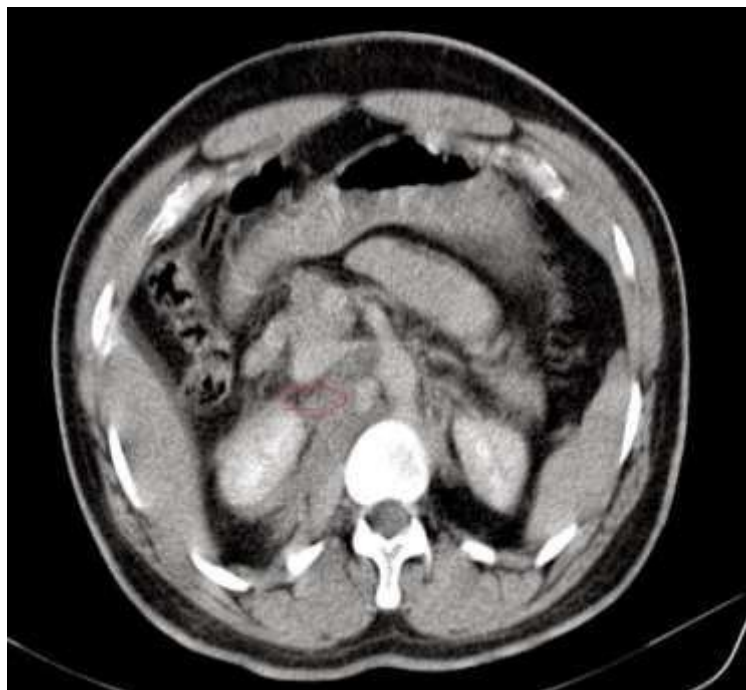
- Image demonstrates small area of contrast extravasation from the lateral margin of abdominal aorta with retroperitoneal haemorrhage.

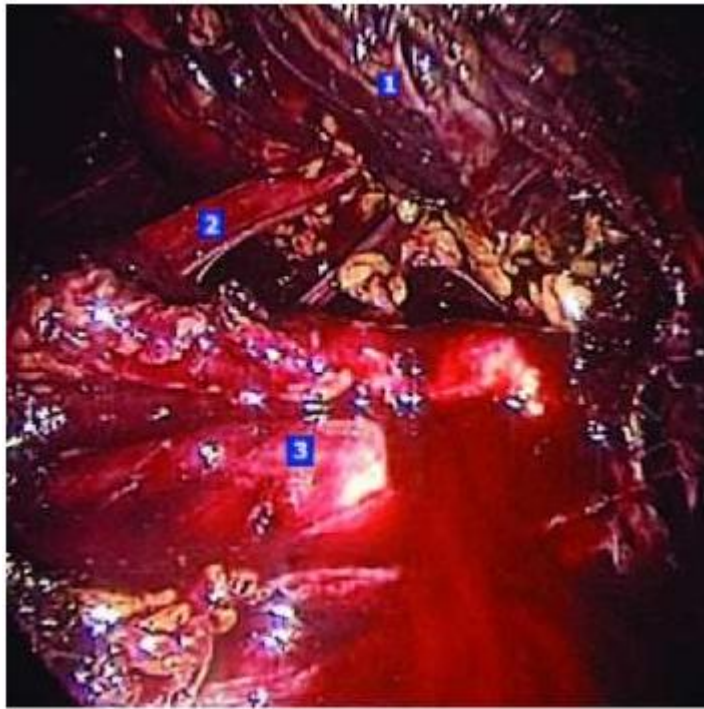
- Intra-operative photo showing retroperitoneal bleed.

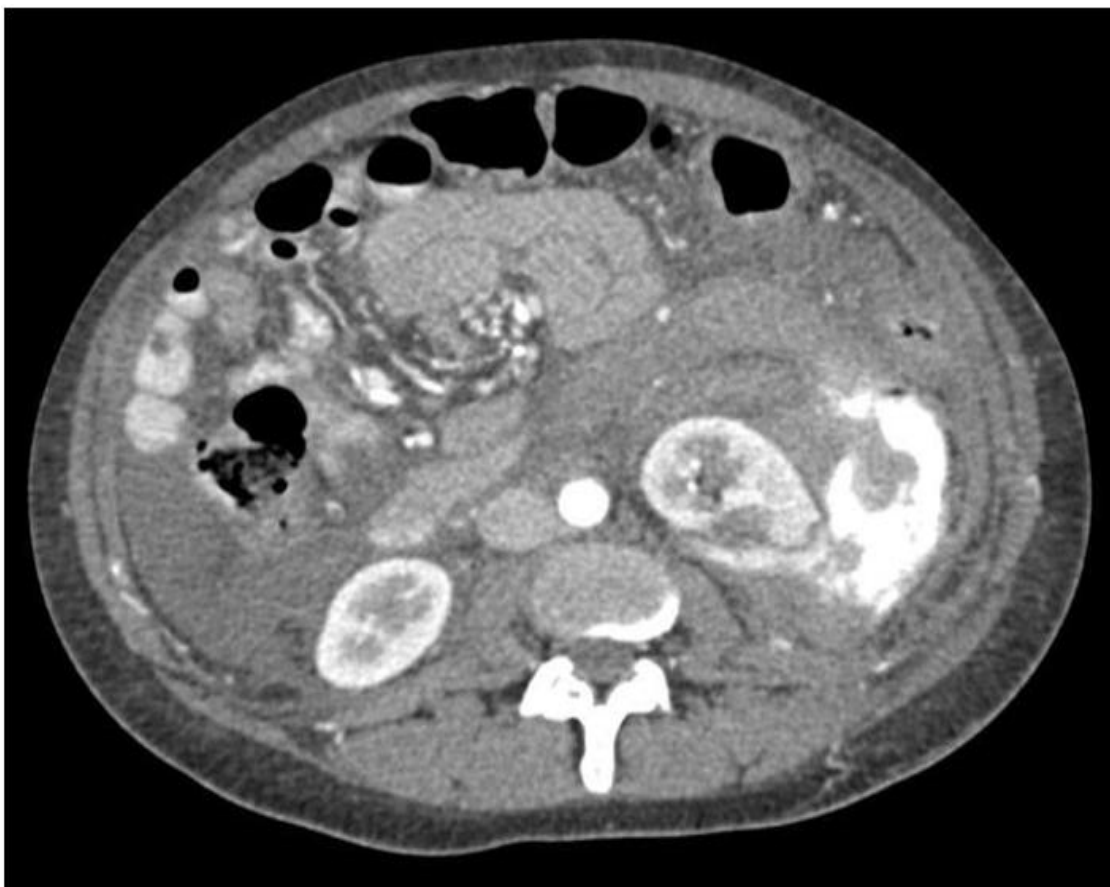
CECT Abdomen & Pelvis showing extravasation of contrast material in left peri-nephric region with renal laceration following blunt abdominal trauma.

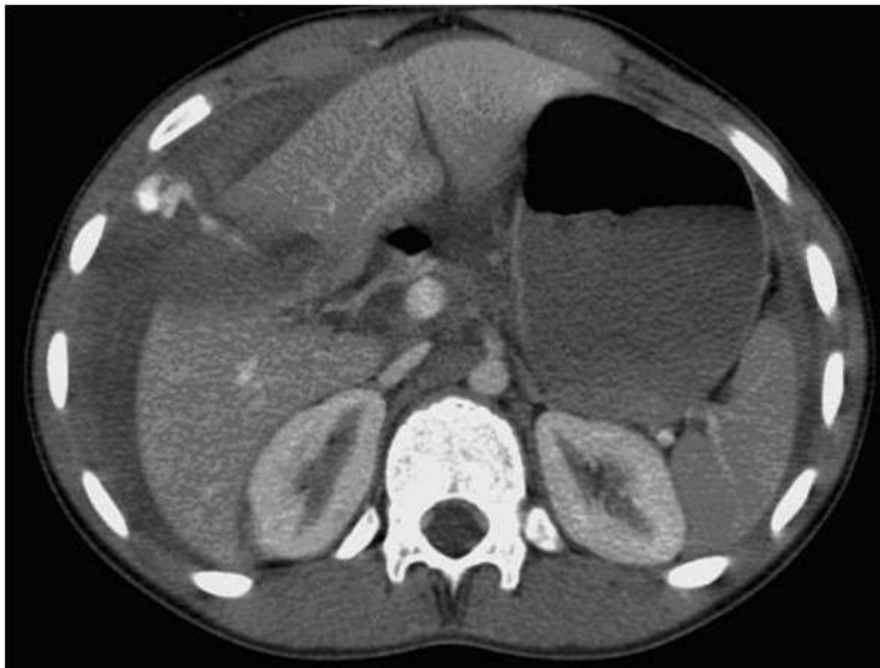
Liver injury with intraperitoneal contrast extravasation visible on computed tomography scan.

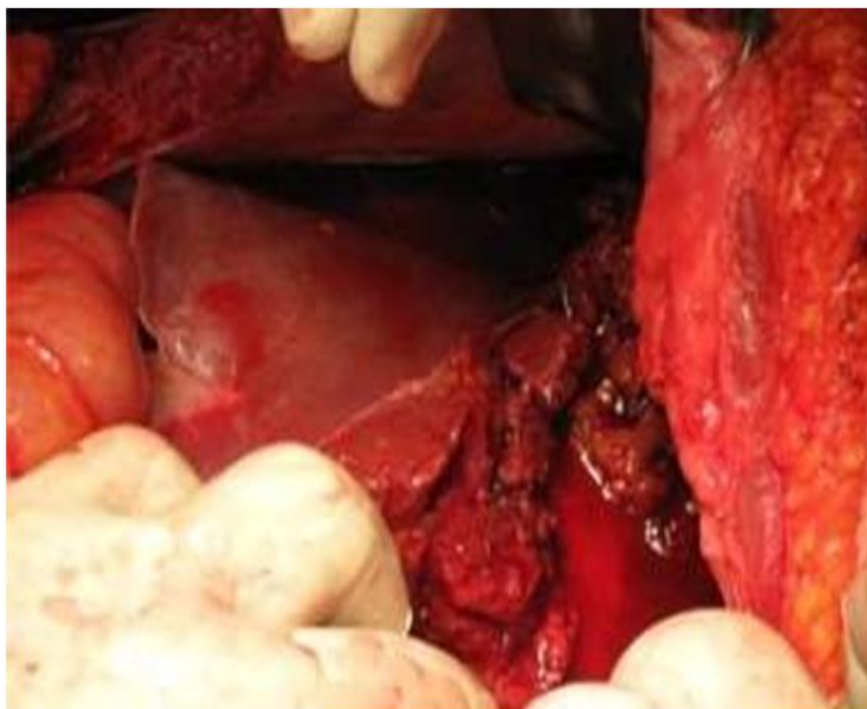
Intra-operative image showing hepatic injury in same patient.

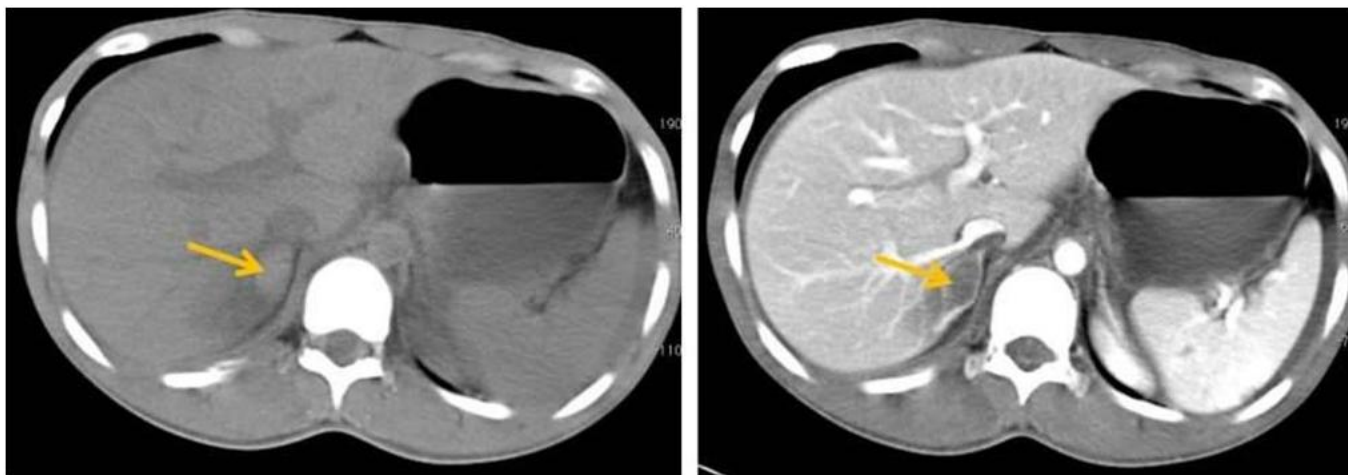
CT scan at the level of right adrenal gland in axial plane soft tissue window pre and post contrast that shows the right adrenal gland haemorrhage as hyperdense on post contrast and relatively hypodense on pre contrast image.

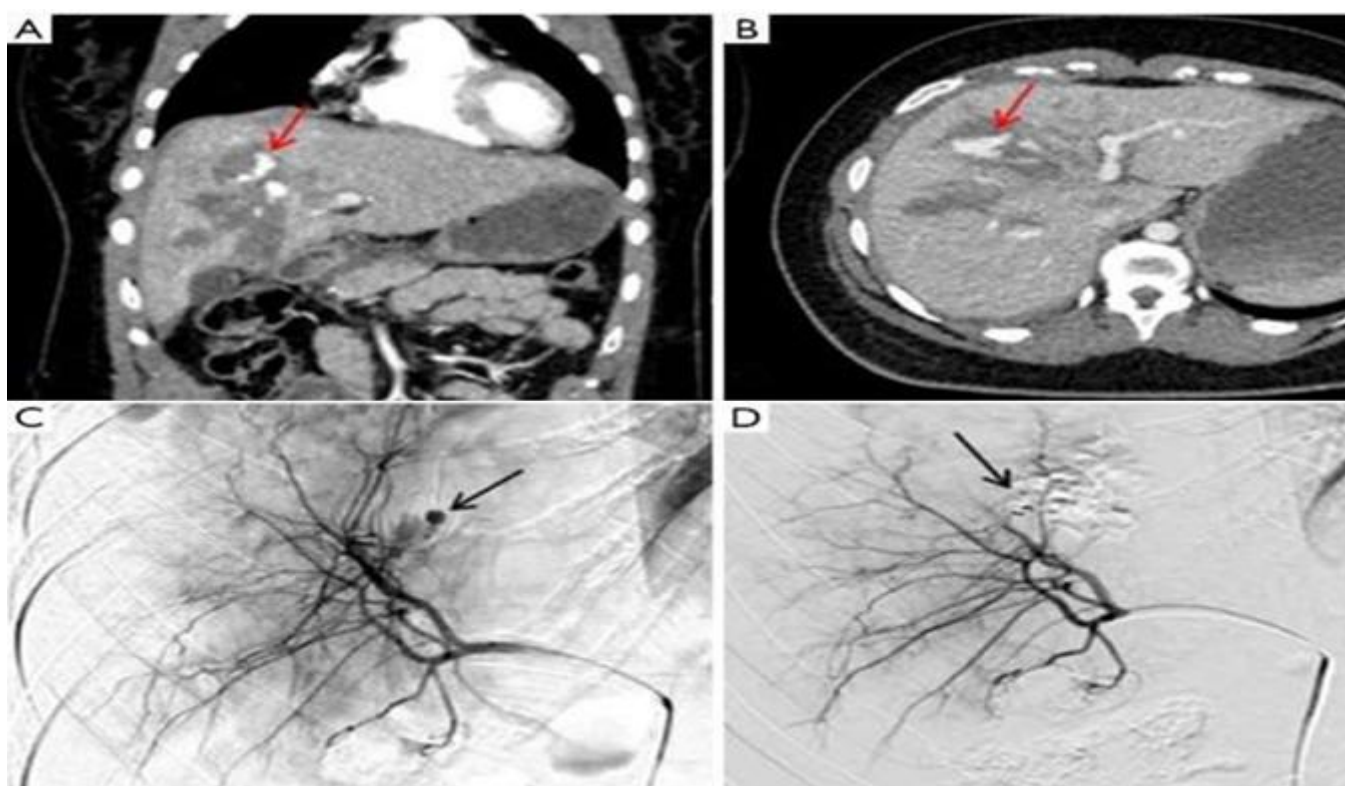
Axial (A) and coronal (B) images of the CT with contrast through the liver shows a large grade V laceration with active contrast extravasation/bleeding (red arrow); (C) selective angiogram of the right hepatic lobe demonstrates a pseudoaneurysm with active contrast extravasation/bleeding from an arterial branch (arrow); (D) post coiling shows satisfactory hemostasis (arrow).

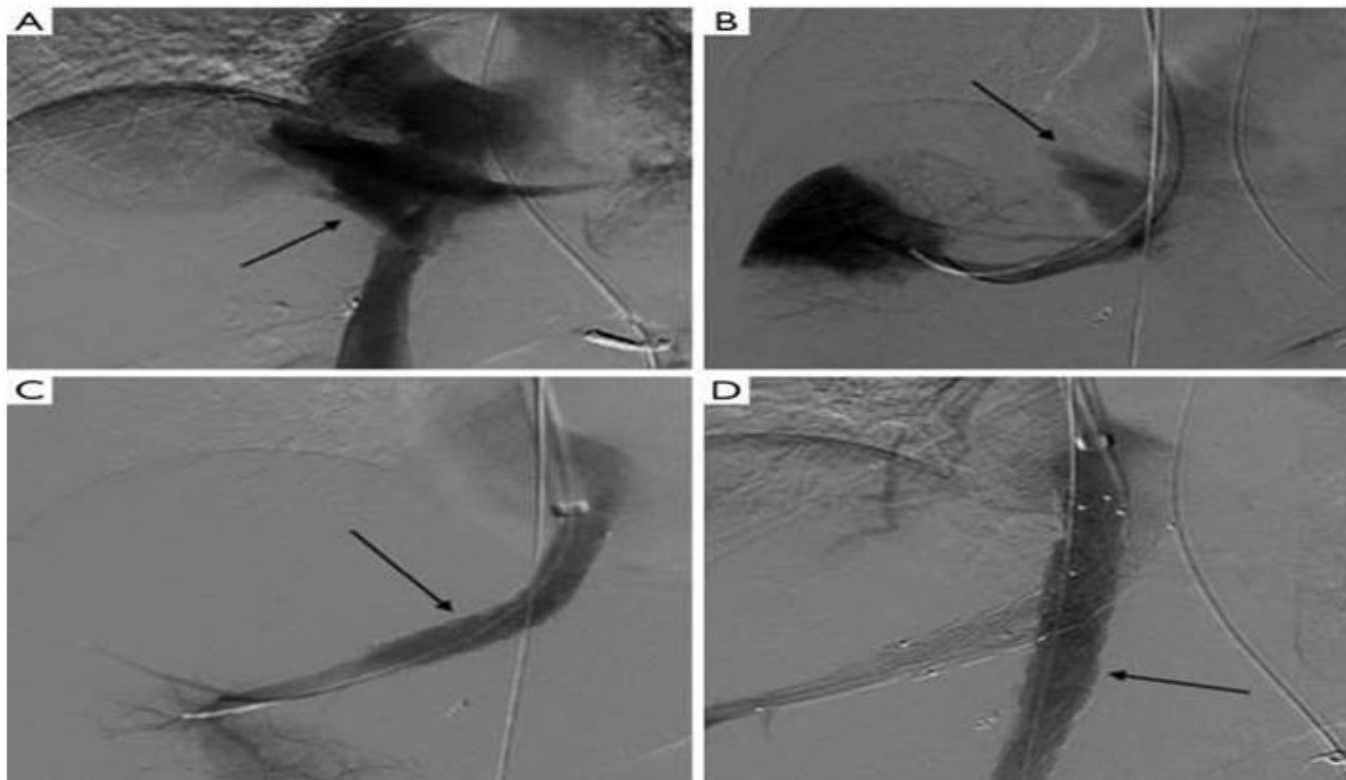
(A) DSA images of a cavogram and (B) hepatic venogram show active extravasation of contrast from the junction of hepatic veins with IVC, consistent with traumatic disruption of hepatic vein from IVC (arrows); (C) subsequently, a covered stent was placed from the hepatic vein into the IVC (arrow); (D) a second covered stent was put in the IVC to maintain antegrade flow (arrow). DSA, digital subtraction angiography; IVC, inferior vena cava.

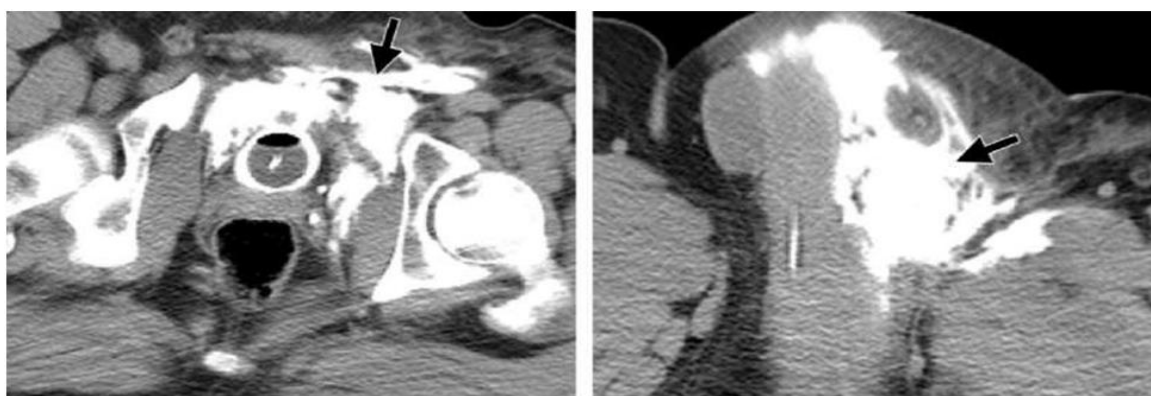
a. Axial whole-body CT angiographic image shows a complex extraperitoneal bladder rupture with extravasation of contrast material into the abdominal wall (arrow). An associated open-book pelvic fracture also was present.

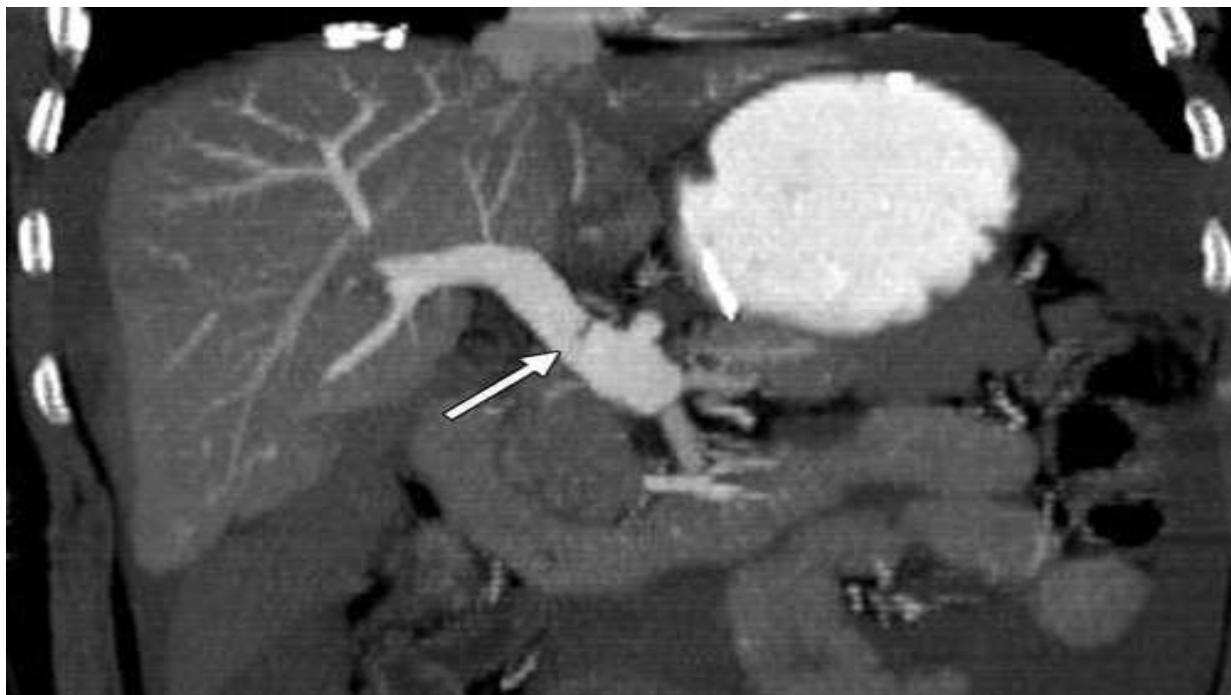
Image showing focal hypoattenuation within the main portal vein following blunt abdominal trauma, suggestive of venous injury.

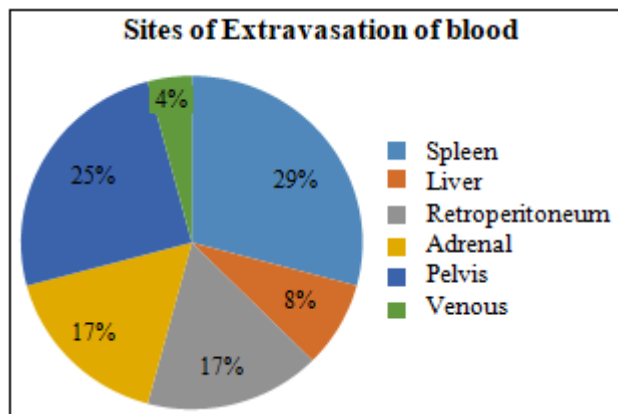
- The location of extravasation of contrast material as seen on CT scan included the spleen (seven), pelvis (six), retroperitoneum (four), kidney (four), liver (two) and adrenal gland (one).
- One patient had venous extravasation.

- The origin of bleeding was confirmed in all cases to correspond to the anatomic region of extravasated contrast on CT.
- The CT attenuation of active haemorrhage ranged from 75 to 350 HU (Mean 144 HU).
- Clotted blood revealed CT attenuation range of 45 to 65 HU (Mean 55), significantly differing from values of active haemorrhage.
