Rectification of Sheath Faults Observed in Power Cables and Accessories in EHV Cable Circuits

Abstract: *This study addresses the occurrence and rectification of sheath faults in EHV XLPE cables; Primarily focusing on external interference leading to cable outer jacket damage. Various corrective actions are explored based on fault location, with detailed processes outlined for rectifying sheath faults over power cables, including fault isolation and layer reinstatement. While not imposing a direct threat to the functionality of the power cable; sheath faults can directly affect the cables current carrying capacity and can lead to the deterioration of subsequent cable layers in case it was not rectified. This comprehensive examination highlights the importance of fault identification and rectification for ensuring the reliability of EHV XLPE Cables in power transmission systems.*

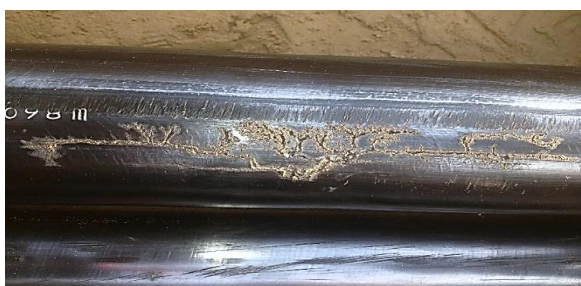
Figure 1: Power Cable Oversheath Fault

For faults that develop on the outer jacket of the power cable, as seen in figure 1, the power cable rectification method is a process in which the fault is isolated and different layers are instated to replace different components that were damaged by the fault.

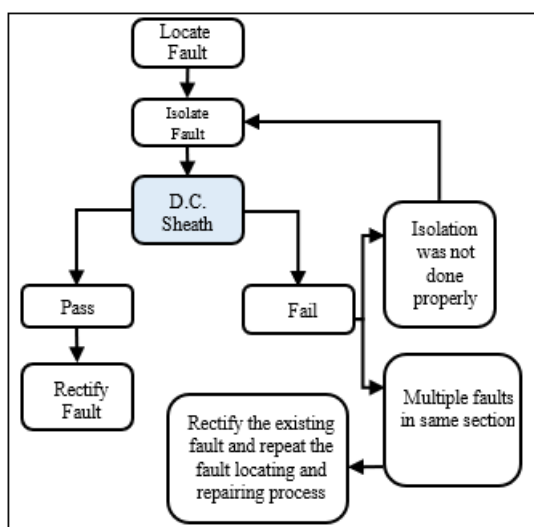
Figure 2: D.C. Sheath Test After Isolation

- 1) The fault is located and confirmed visually.
- 2) The fault is isolated by removing the semi conductive layer atop the cable's outer sheath.
- 3) A D.C. sheath test is carried out to ensure that the fault was isolated. If the fault was isolated, then it would not have a path to ground. The D.C. sheath test isolation criteria is summarised in figure 2.

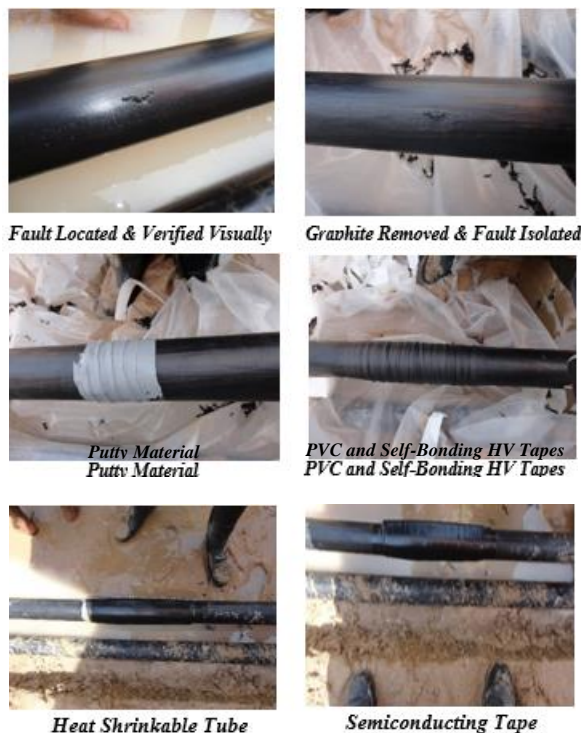
Figure 3: Sheath Fault Rectification

The Power Cable sheath fault rectification procedure, as illustrated in figure 3, is as follows:

- 1) Putty material is used to fill-in any crevices that might have formed due to the breakdown of insulation. Then a full wrap around the cable's circumference is done using this putty material to create a unified smooth layer.

- 2) A series of PVC and HV Tapes follows to reinstate the damaged insulation layers.
- 3) A heat shrink tube is added to ensure that the newly instated layers are secured.
- 4) A semi conductive layer is applied at the top for continuity purposes during cable sheath testing.

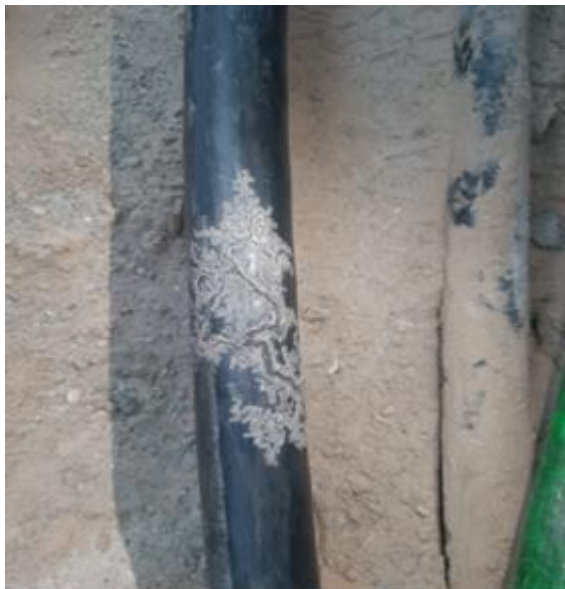
Figure 4: Bonding Cable Sheath Fault

In these cases, the defected parts can simply be replaced or repaired. For the bonding cable defect/damage on the oversheath only, as shown in Figure 4, the repairing can be done by cleaning the damaged area on the oversheath, applying insulating tapes, self-bonding tapes and heat shrinkable tube on the damaged portion. The final repaired bonding cable can be seen in Figure 5.

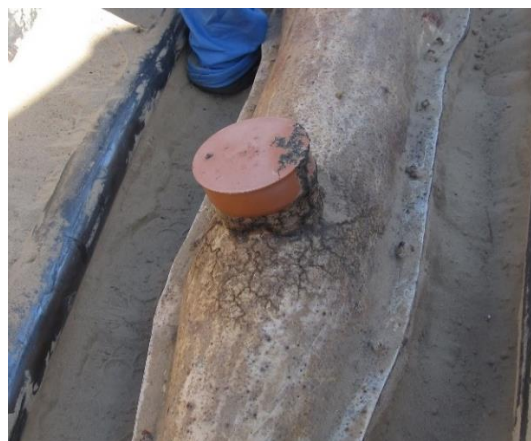
Figure 6: Sheath Fault in Cable Joint

A common example in joint sheath faults is due to the improper instatement of the filling compound. Different joint makes have different compound requirements; Some joints use a hot compound such as bitumen that hardens as it cools, while others use a resin compound that hardens when mixed with an activator.

During the jointing process the compound must be completely set, however due to improper curing and mixing of compounds it has been found that the inner compound in some cases is still in liquid form. The improper instatement of the compound makes it lose its electrical properties, hence contributing to the development of a sheath fault. In figure 6 we can observe signs of electrical treeing on the joint's protection box due to improper compound mixing and filling.

Different site conditions such as temperature, humidity, and precipitation also affect the instatement of the inner compound, hence a proactive jointer must be able to identify these uncontrollable factors and counteract them appropriately. The rectification method that is implemented is to remove these components up to the metallic tube/casing of the joint. A detailed physical inspection occurs to ensure that there are no traces of carbonisation to ensure that the result of sheath fault is because of the coffin box, gasket or filling compound. Reinstatement of the required layers of PVC HV tapes, heath shrink tubes, coffin box, gasket and filling compound take place to clear the sheath fault.
