Full Mouth Rehabilitation of Severely Worn Dentition: A Case Report

“Ss Cyril and Methodius” University – Skopje, Macedonia, Faculty of Dentistry

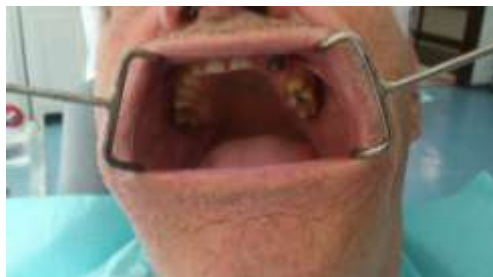
Figure 1: Intraoral view – maxilla

A 71- year old partially edentulous male patient referred to the UDCC Department for removable prosthodontics in Skopje. On the clinical examination was observed severely worn dentition with missing teeth: 22, 24, 31, 36 and 41.

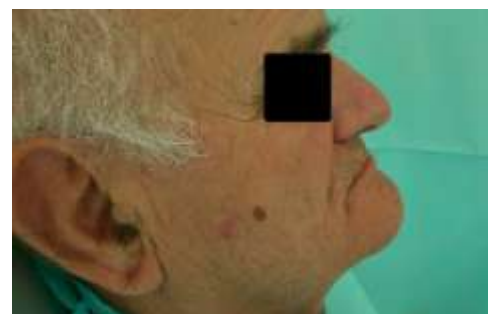
Figure 4: Decreased VDO

The patient's main complains were about having mastication difficulty and generalized sensitivity of tooth. The patient also suffered from TMJ pain and frequent headaches. The patient's facial appearance shows signs of decreased VDO, with shortened (collapsed) lower third of the face and drooping commissures. Before making any treatment decisions we mounted and analyzed the plaster casts. It was obvious that the patient's VDO had to be increased to a proper, comfortable position. [4,5] . After analyzing the plaster models of the lower and upper jaw, decision for treatment was made. The main goal of the treatment plan

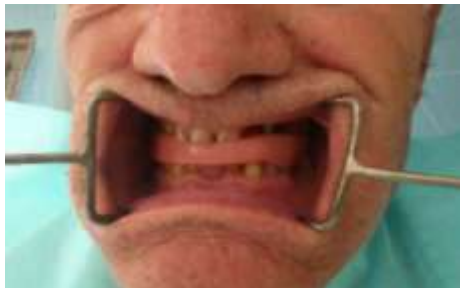
Figure 2: Mandibular splint

was to establish VDO which would provide good mastication, acceptable aesthetics and TMJ pain relief. The treatment procedure was explained to the patient and with his agreement we continued as it was planned. For correction of the VDO an occlusal mandibular acrylic splint was made. The VDO was increased for 6mm. The patient was suggested to wear the occlusal splint while sleeping and 4-6 hours during the day.

In literature the period of adaptation to the increased VDO is different from 3 weeks to 5 months wearing time for mandibular splint to 2-6 months for fixed provisions [9,14,15]. In our case because of economics reasons, on patients request, we skip the provisions and after 3 months of adaptation period with mandibular occlusal splint the final metal ceramic crowns and bridges were made.

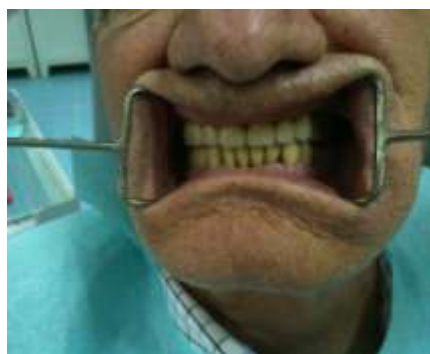
Figure 3: Metal-ceramic restoration

In the meantime, the necessary pre-prosthetic treatment was implicated, the old tooth fillings were changed, persisting caries was removed as well as the periodontal treatment required. Regular check up were provided. The occlusal splint usage resulted in decreasing of joint pain. Once the new VOD was approved and accepted, followed for period of three months, the patient was prosthetically taken care of. He received metal ceramic crowns and bridges in the upper and lower jaw. The maxillary and mandibular teeth were prepared simultaneously. The restoration maintained stable centric contacts in the post-canine region and light anterior contact. Before finalizing the metal-ceramic restoration the aesthetics, phonetics, canine guided occlusion, protrusive and lateral disocclusion were verified. After the patient's approval we finally cemented it with glass ionomer cement. To avoid the possibility of ceramic fractures, returning of TMJ pain and allowing muscles relaxation the patient was provided with silicon night guard.
