Social Construction of Landslide; Case of Aranayake - Political Ecological Glances in Sri Lanka

Abstract: *Landslides have been predominantly studied in Sri Lanka in the category of natural phenomena, highlighting geological, geomorphologic and meteorological attributes. Although improper land use practices are identified as a contributing factor for landslides, the larger political and ecological context that leads to such improper land use practices have not been, both empirically and theoretically, adequately dealt with. The objective of this study is to analyze the phenomenon of landslides as socially constructed. In order to understand landslides as socially constructed, this study focuses on the recent landslide of Elangipitiya from the political ecology approach which is presumed upon a relationship between politics and natural environment. In this study, we applied Paul Robins approach to political ecology which focuses on knowledge, power and practices as contributing elements towards environmental degradation, operating at macro to micro levels. This study reveals that land use practices in Elangipitiya have evolved from an undisturbed forest to a tea plantation and then

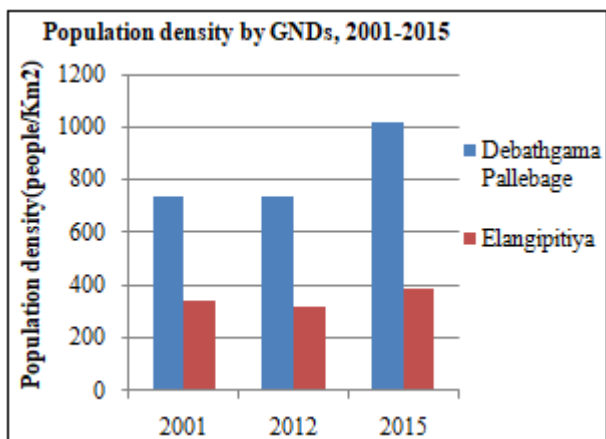
According to the meteorological department data Aranayake gets 1825.5mm annual average rainfall in contrast May of 2016 got 990mm of rainfall. Besides those natural environmental factors, population expansion of the study area illustrates in the following figure 3.

Figure 3: Population density expansion of Elangipitiya
Source: Divisional Sectararian office –Aranayake

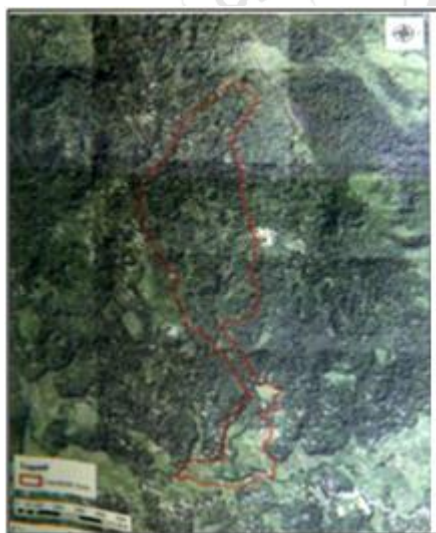
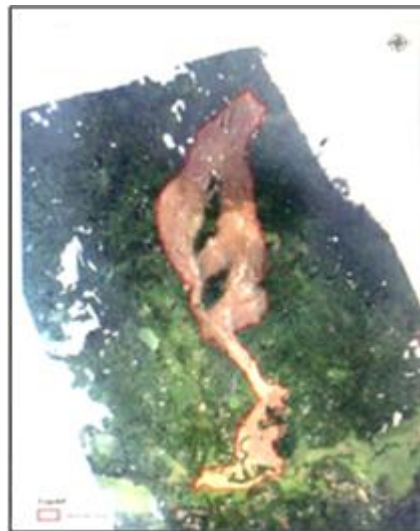
Figure 4

Following figure shows the drone image of the affected area.

Affected area before landslide

Affected area after the landslide
