International Journal of Science and Research (IJSR)
ISSN (Online): 2319-7064
Index Copernicus Value (2015): 78.96 | Impact Factor (2015): 6.391

Geotechnical Stability Performance of Batubesi Dam
A Review of Seismicity Impact on Structural Dam Safety

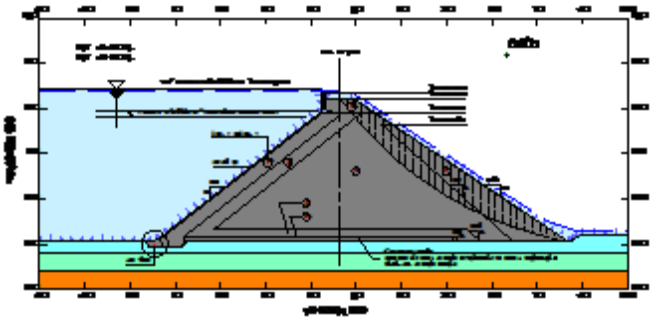
Figure 9: Slope Stability with PGA = 0 g, Maximum Water Level, El. +324.10 m amsl, FoS = 1.10

In case of probable maximum flood (PMF) occurs without presence of earthquake, safety factor (FoS) of the dam is 1.10; on the other hand when the probable maximum flood (PMF) coincidentally occurs together with the earthquake event simultaneously, by design the dam structure may not be collapsed since the emergency spillways (fuse plugs) working on the spill point at El. +321.00 m amsl to spilling out the excessive water level.

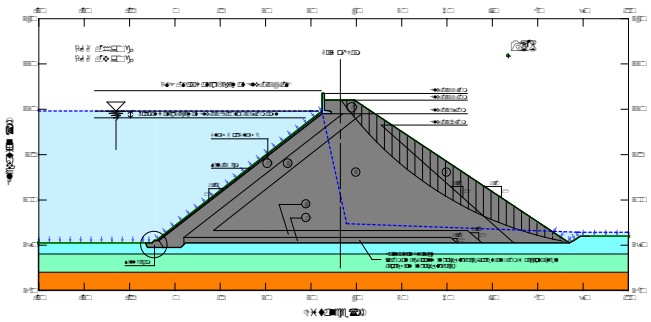
Figure 10(a): Slope Stability with PGA = 0.0 g, NHWL, El. +319.60 m amsl, FoS = 1.66

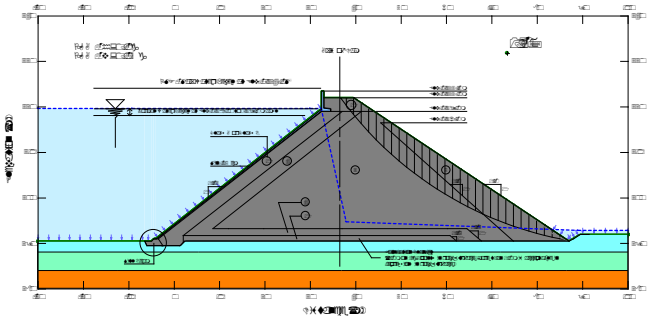
Figure 10 (b): Slope Stability with PGA = 0.1 g, NHWL, El. +319.60 m amsl, FoS = 1.37

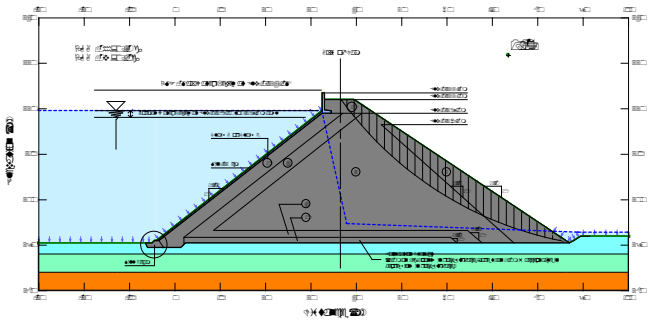
Figure 10(c): Slope Stability with PGA = 0.2 g, NHWL, El. +319.60 m amsl, FoS = 1.17

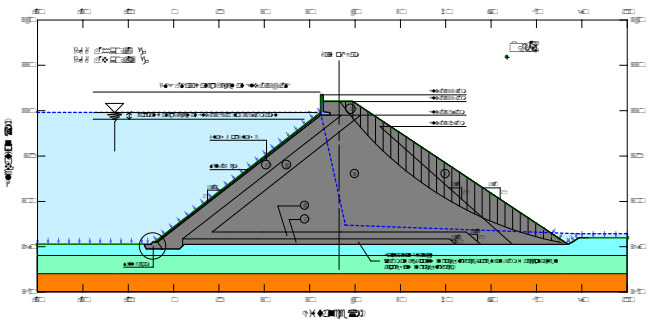
Figure 10(d): Slope Stability with PGA = 0.35 g, NHWL, El. +319.60 m amsl, FoS = 0.96

In normal high water level (NHWL) without presence of the earthquakes, it may provide safety factor of the dam about 1.66, meanwhile the presence of the earthquake with seismic load about 0.35g it may provide safety factor about 0.96 which is not complying with the minimum requirement.

Additional technical review and discussions by means of finite element method to obtain stress deformation, stress-strain relationship behavior, and potential displacement (level of damage) should be conducted to evaluate status of the dam safety in the dynamic failures. Although the safety factor (FoS) on some conditions are less than 1.00 under seismic loading it doesn't mean the dam structure may collapsed. Further geotechnical stability of the dam structure should be reassessed using dynamic analysis model whether or not the deformation exceeding half of the freeboard; when it occurs, the dam structure assumed will be failed.

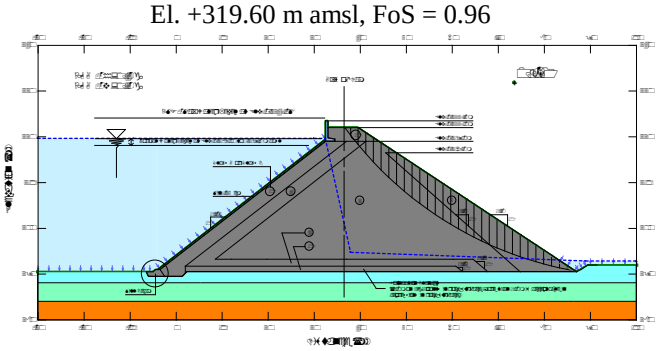
Figure 10(e): Slope Stability with PGA = 0.40 g, NHWL, El. +319.60 m amsl, FoS = 0.91

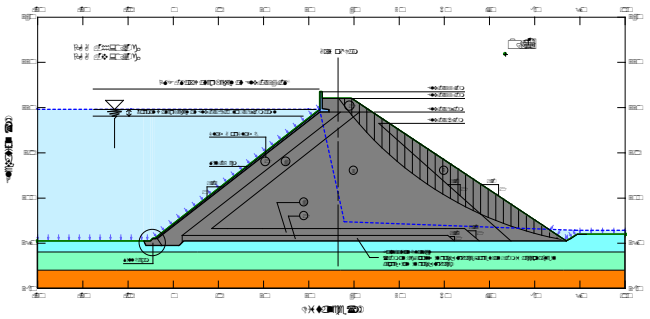
Figure 10(f): Slope Stability with PGA = 0.60 g, NHWL, El. +319.60 m amsl, FoS = 0.75

Retrofitting program as part of the dam structure remediation had been done by PT Vale Indonesia Tbk by means of constructing counterweight at the toe of downstream slope face in order to strengthen geotechnical stability of the dam to comply with the required factor of safety (FoS) against maximum considered earthquakes at Sorowako site-specific.
