Identification of Composite Insulator Failures in Service: A Utility Experience

Abstract: *High-voltage insulators are critical to the reliability of power transmission systems. This study explores the degradation issues of composite insulators and presents the implementation of Reliability-Centered Maintenance (RCM) at DEWA. Using advanced inspection tools such as UV and IR cameras, hydrophobicity tests, and laboratory analyses, the research identifies defects and outlines preventive strategies. The findings underscore the value of adopting RCM for early detection, enhancing reliability, and optimizing the economic lifespan of insulators.*

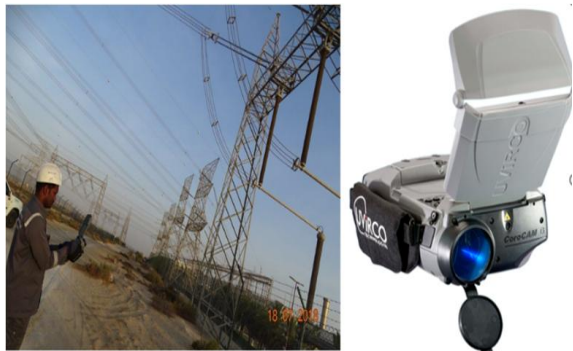
Figure 1: UV Site Inspection & UV Camera

In 2013, DEWA introduced advanced, non-invasive inspection equipment to support this RCM approach. One such tool is the Ultra-Violet (UV) Corona Camera, as shown in Figure 1. This camera is specifically designed to monitor the condition of composite insulators by capturing real-time video and images that reveal corona discharge, sparking and arcing along the transmission lines. These detailed visuals allow DEWA inspectors to pinpoint the exact locations of issues on the insulators, providing crucial data for diagnosing potential problems and planning targeted maintenance interventions.

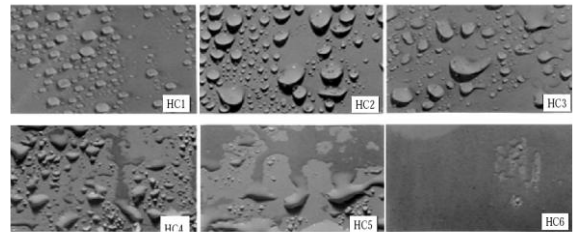
Figure 7: Characteristics of insulator surface HC1-HC6

The results from the hydrophobicity test were compared to the six hydrophobic classes outlined in Figure 7, where HC1 denotes the most hydrophobic and HC6 the most hydrophilic in accordance with the IEC TS 62073 Standard [3]. Upon comparing Figures 6 and 7, it was evident that water droplets did not remain on the insulator surface, indicating a loss of hydrophobic properties. This categorises the defective insulator under HC6, signifying significant degradation of the insulator.
