# Integration of a Maxillary all Ceramic Fixed Partial Denture with Zirconia Framework: A Clinical Report

**Abstract:** *The integration of a maxillary all-ceramic fixed partial denture (FPD) is esthetically, functionally and periodontally demanding. It requires careful study, correct diagnosis, appropriate decision and impeccable implementation. We report the case of a patient claiming the replacement of a defective metal-ceramic FPD replacing the maxillary first premolar (24) and supported by the canine (23) and second premolar (25). The problems found were a reduced prosthetic occlusal height (POH) due to hypertrophy of the edentulous ridge, a reduced coronal height and a poorly aligned free gingival margins. The decision was to make a new all-ceramic FPD with zirconia framework. Corrective surgery of the edentulous ridge was performed in the preprosthetic phase. Tissue healing was guided by a transitional prosthesis. A period of 6 months was required for the final maturation. The choice of the material as well as the prosthetic design made it possible to make a compromise between the biological, aesthetic and mechanical requirements.*

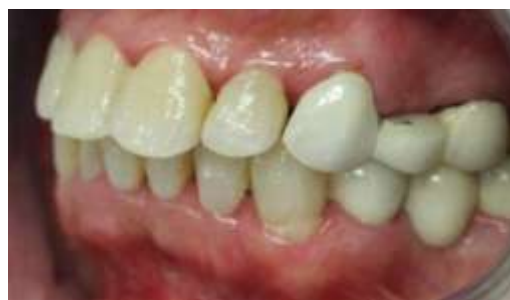
The retainer on the 25 had a short coronal height and a poor marginal fit. A mal-aligned free gingival margin, an unsatisfactory morphology and a sharp color contrast were notably recorded (Fig.1).

**Figure 1:** Vestibular view of the old bridge. Note the cervical grayish brown colour at the mesial side of the tooth 25

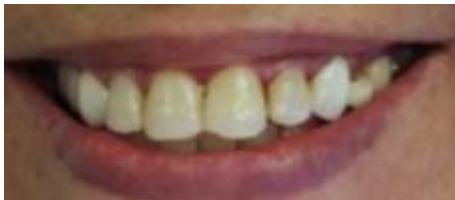
Examination of the occlusion showed normal functions with an efficient anterior guide. The antagonist teeth were rehabilitated by a satisfactory metal-ceramic restoration. Natural teeth were of low translucency. The smile examination showed a broad smile revealing the maxillary teeth to the mesial faces of the first molars. The patient had a medium smile line (Fig.2).

**Figure 2:** Examination of forced smile

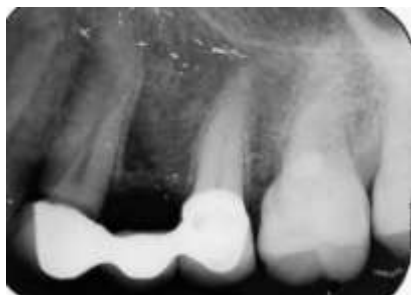
Periapical radiograph showed a crown to root ratio less than 1 at the level of the abutment teeth and a bone trabeculae rarefaction in edentulous ridge zone was noted (Fig.3).

**Figure 3:** Periapical radiograph in the area of the bridge. Note the poor adaptation of the dento-prosthetic joint and the absence of the interproximal contacts.

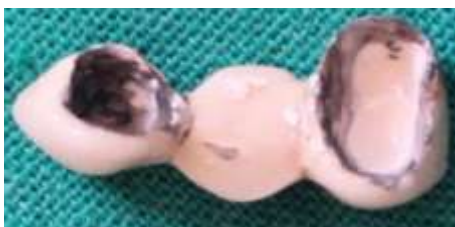
The space between the gingival surface of the pontic and the residual ridge crest was measured. This space, occupied by the soft tissues, was exaggerated (about 5 mm). A provisional diagnosis of a gingival hypertrophy was retained. Moreover, a small height of the pontic metallic core was noted (Fig.3). This could be at the origin of the fracture of the fragile cosmetic ceramics by the lack of support [2]. After getting informed consent from the patient, the fixed partial denture was removed successfully without destruction. A well opened prosthetic embrasures on either side of the pontic (Fig.4) and a reduced cross sectional area of the connectors were observed.

**Figure 4:** Removed defective restoration: Note the irregularity of the cervical margins as well as the excess cement adhering to the gingival face of the pontic

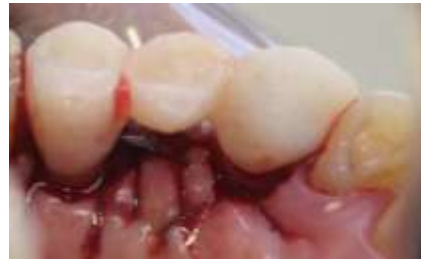
**Figure 12:** Note the new supra mucosal situation of the pontic after remodeling of the edentulous ridge

**Figure 13:** Buccal view: note the increase in the POH and a lengthened clinical crown of tooth 25

In a subsequent session, the surgical phase was initiated. The edentulous ridge was reshaped by oral mucosa thinning. In addition, a surgical crown lengthening was performed at the level of the maxillary second premolar (25) (Fig. 12, 13).

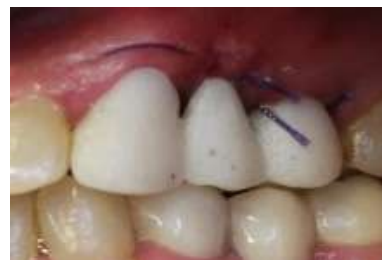
**Figure 14:** Vestibular view of the lined transitional prosthesis. Note its adaptation to the new situation of the soft tissues with open embrasures.

During a follow-up visit, 4 days later, we examined both the periodontal tissues and the provisional FPD that will guide the tissue healing. We insisted on the well-opened embrasures, made possible by the increase of the POH resulting from the surgery (Fig.14). The sutures were removed on the 10th day of surgery. After about 3 weeks, the preparations were rectified, and then a non-compressive global impression was achieved and sent to the laboratory to produce a transitional prosthesis made in thermoplastic resin. This resulted in tissue maturation under the best conditions.

Hermetic stitches were performed and instructions were given to the patient to avoid all factors disturbing hemostasis. Afterwards, the cervical margins of the retainers and the gingival surface of the pontic were lined with autopolymerizing resin. Careful polishing was the rule and then the provisional restoration was cemented. Special care should be given to eliminate cement excess to avoid gingival irritation (Fig. 14).

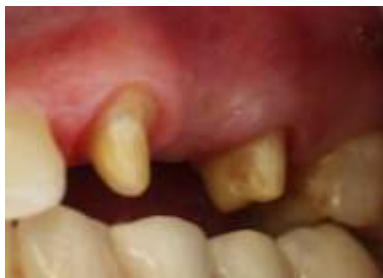
Six months were considered sufficient to achieve final tissue maturation [3](Fig.15).

**Figure 15:** Buccal view: Note the soft tissue maturation

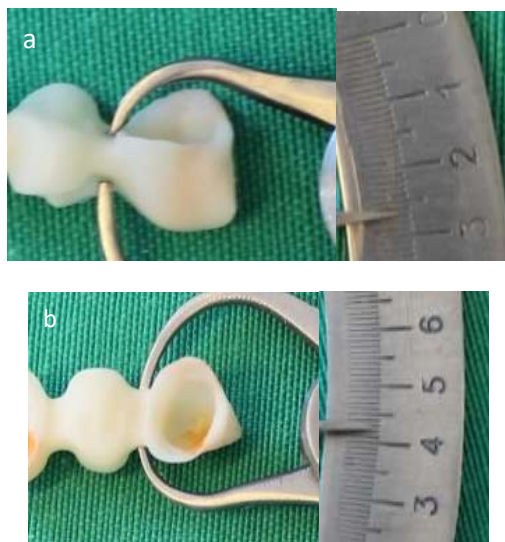
Consequently, a non-compressive global impression was performed by double mix impression technique. Then, the color of the ceramic framework was chosen. A 3-unit zirconia framework (Y-TZP) was fabricated by Indirect CAD-CAM technology (Computer Aided Design-Computer Aided Manufacturing). Then, we checked the design of the framework. We particularly examined, the connectors. We found them sufficiently high, with a cross-sectional area calculated at the mesial connector equal to 8.73 mm<sup>2</sup> and slightly higher at the distal one (Fig.16).

**Figure 16:** Dimensions of the mesial connector: height = 2.7 mm (a) and width = 4.2 mm (b)

In our case the cross-sectional area was 8 to 9 mm<sup>2</sup>, which is in line with the scientific data<sup>(2, 9, 6, 7, 10)</sup>. However, the large increase of the cross-sectional area could be in contradiction with periodontal integration requiring sufficient opening of the gingival embrasures and /or aesthetic integration requiring proper embrasures [7].

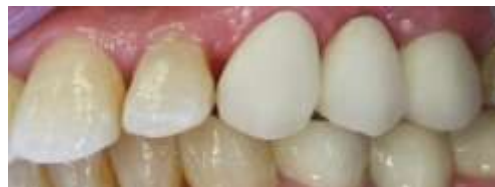
After ceramic application, a try-in appointment in the biscuit bakewas achieved. We particularly checked the opening of the embrasures, as well as the pontic/tissue relationship. Imperfections in morphology and color were detected (Fig.18) and required corrections in the laboratory.

**Figure 18:** Note the difference in color and the overhangs

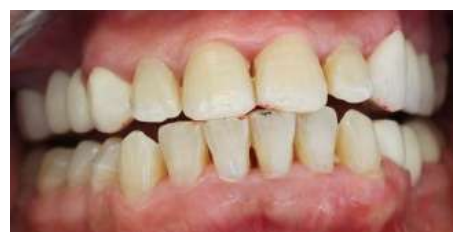
During the next visit, special attention was paid to the static and dynamic occlusal equilibration. In right lateral movement, the contacts were distributed harmoniously according to the canine function concept<sup>1</sup> (Fig. 19 to 21).

**Figure 19:** Functional anterior guidance

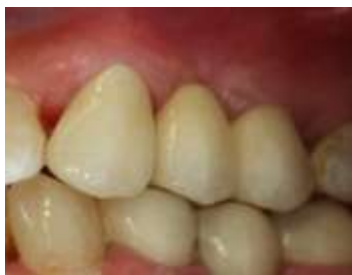
Finally, the FPD was cemented with resin-modified glass ionomer cement (Fig.22). The patient was satisfied with the result. (Fig. 23)

**Figure 22:** Intraoral view
